Office of Health, Safety and Security

Monthly Analysis of Electrical Safety Occurrences

April 2012

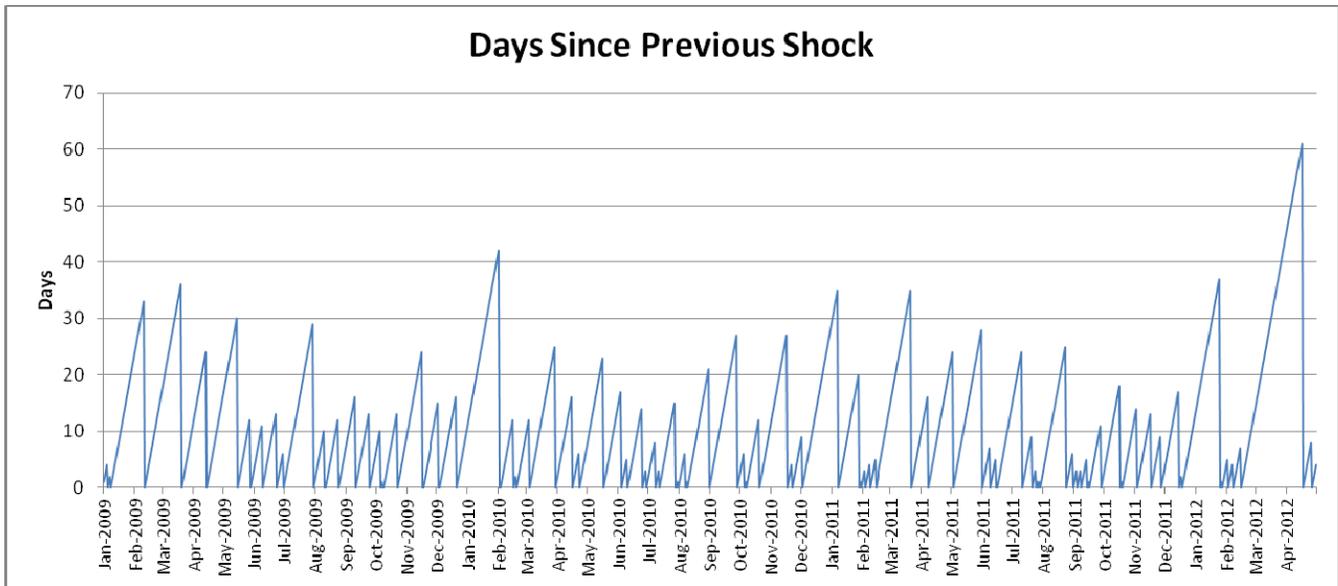
Figure 2 - Days since Previous Shock

Figure 2 shows the number of days since the previous electrical shock for the DOE complex. The longest interval was 61 days as of April 16 and the present interval is 4 days as of April 30.

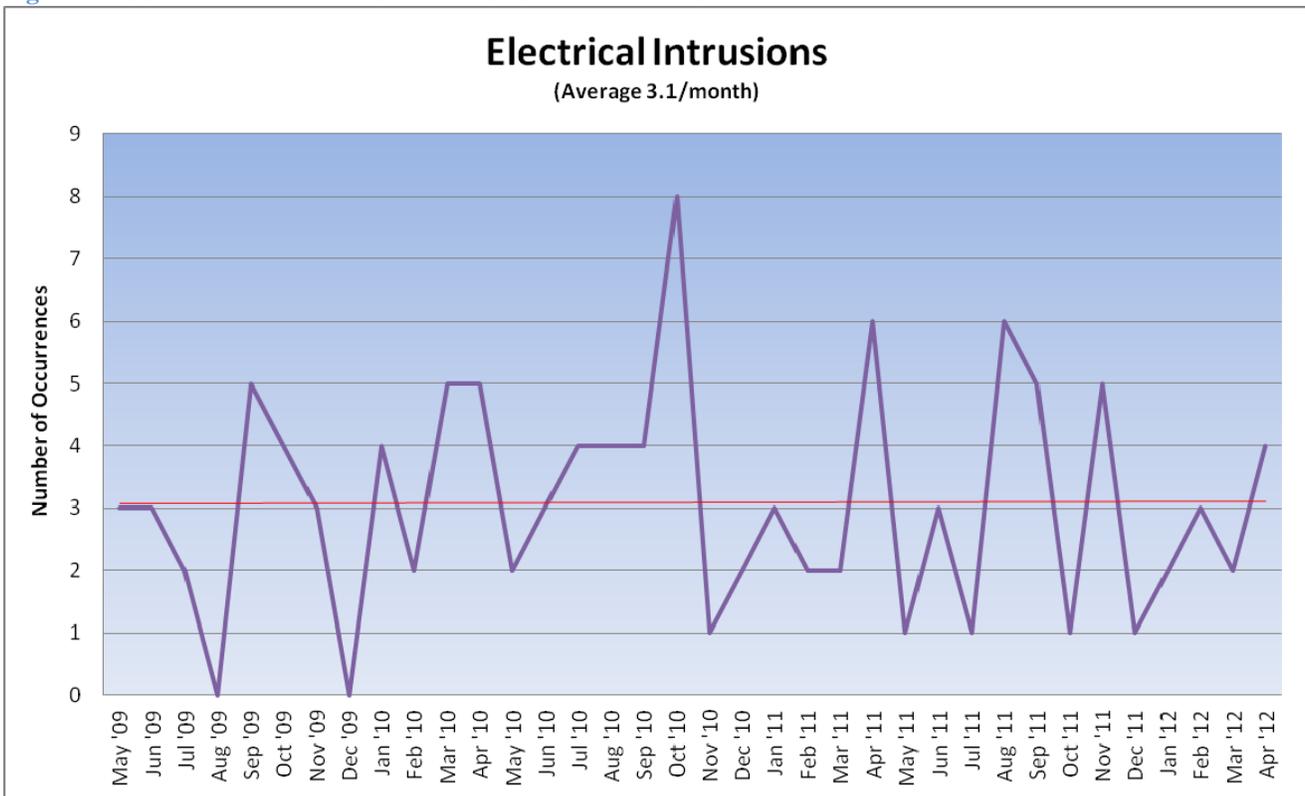
Figure 3 – Three-Year Trend of Electrical Intrusion Occurrences

Figure 3 shows a 3-year trend of electrical intrusion occurrences for the DOE complex. During this period we see that the overall trend has remained flat. There were only two months (2009) when there were no reported occurrences.

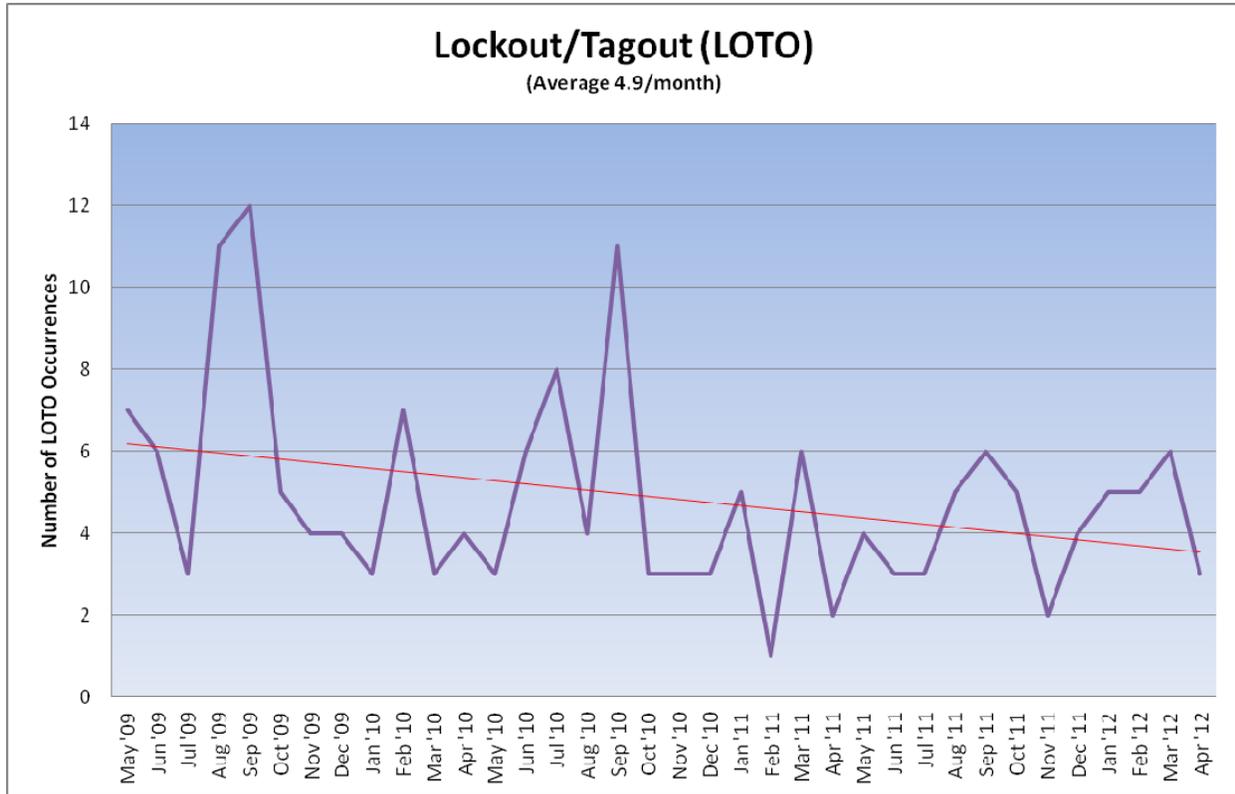
Figure 4 – Three-Year Trend of Lockout/Tagout Occurrences

Figure 4 shows a 3-year trend of LOTO occurrences for the DOE complex. During this period we have seen a general decrease in the number of occurrences involving the implementation of lockout/tagout for electrical work.

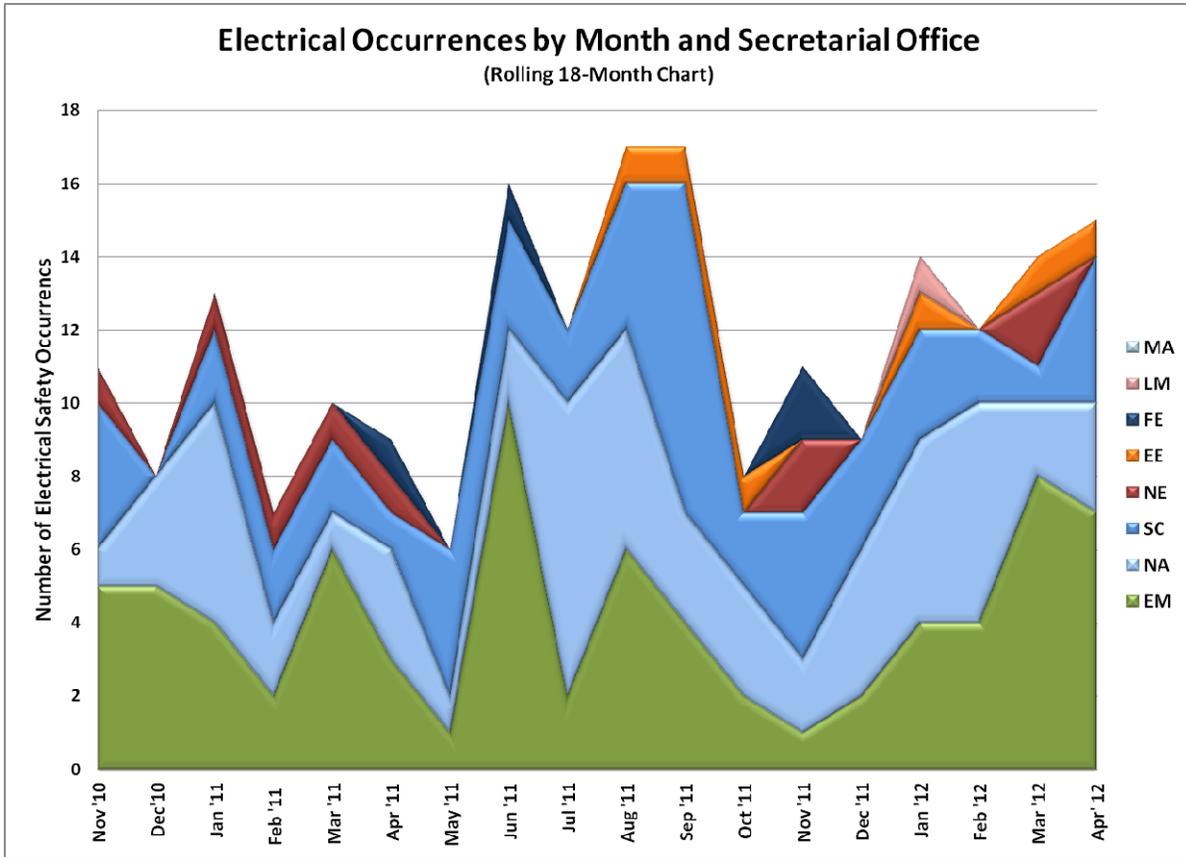
Figure 5 - Electrical Occurrences by Month and Secretarial Office

Figure 5 shows the distribution of electrical safety occurrences by Secretarial Office. The Office of Environmental Management (EM), the Office of Science (SC), and the National Nuclear Security Administration (NA) typically report the most occurrences of all the offices. Over the past several months EM has increased while NA and SC decreased until April.

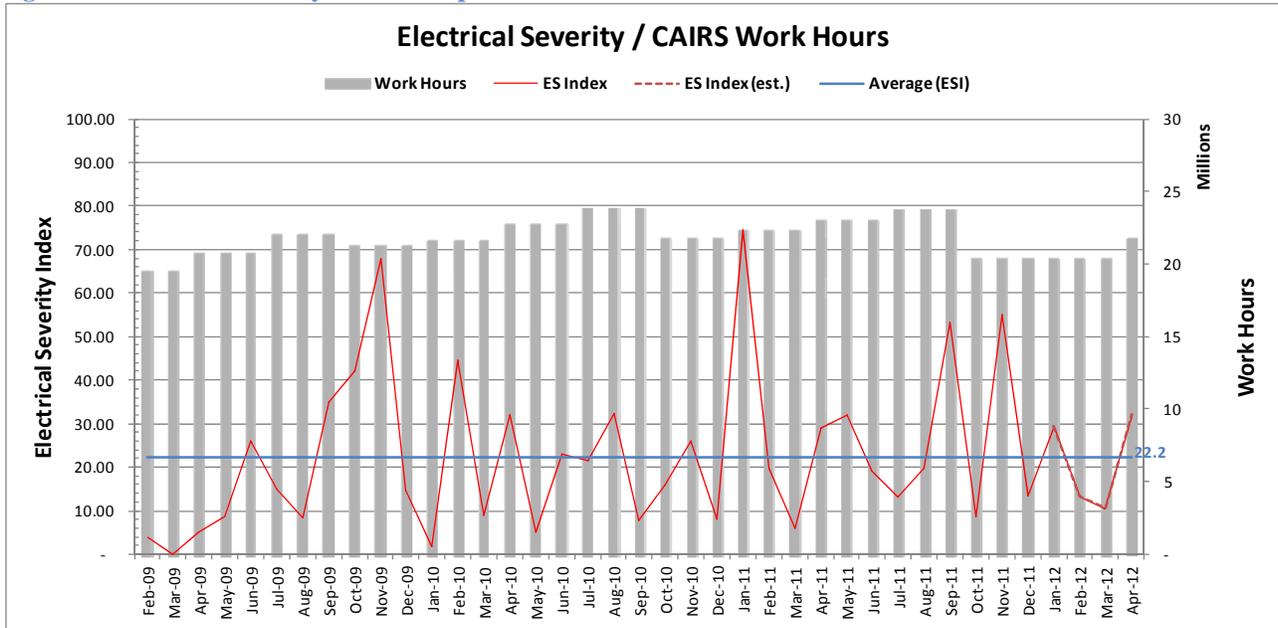
Figure 6 - Electrical Severity Index Compared to Work Hours

The Electrical Severity Index (ESI) is a performance metric that was developed to normalize events against organizational work hours. The ESI is calculated monthly and trended. Figure 6 shows a calculated ESI for the DOE complex and Table 4 shows the ESI and how it has changed from the previous month.

Note: An estimated ESI is calculated until accurate CAIRS man-hours are available. The chart is updated monthly.

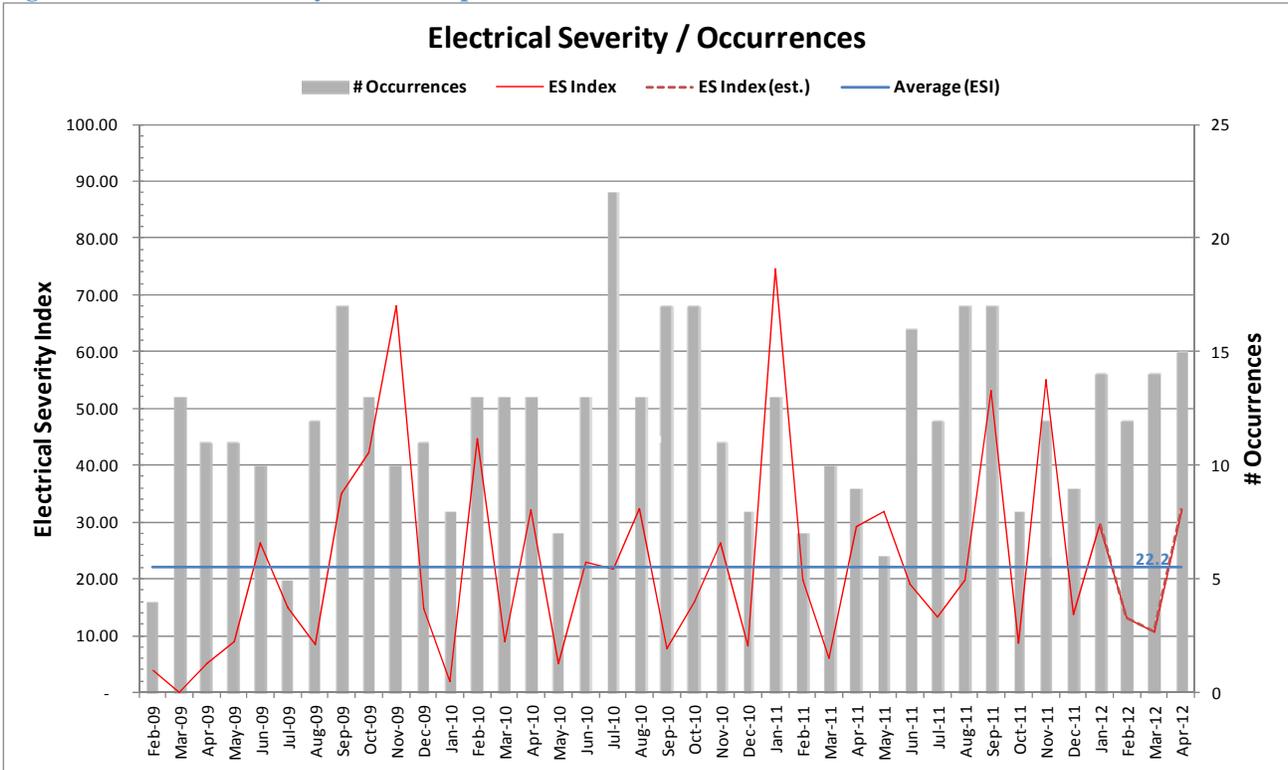
Figure 7 - Electrical Severity Index Compared to Number of Occurrences

Figure 7 shows the ESI with the number of Occurrences instead of Work Hours.

Following a decrease over the past two months, the average ESI (22.2) has increased. The lowest average ESI was 19.2 in June 2010. Figure 8 shows the number of days since the previous high severity occurrence. The present interval is 363 days as of April 30. The previous longest interval was 181 days in 2009.

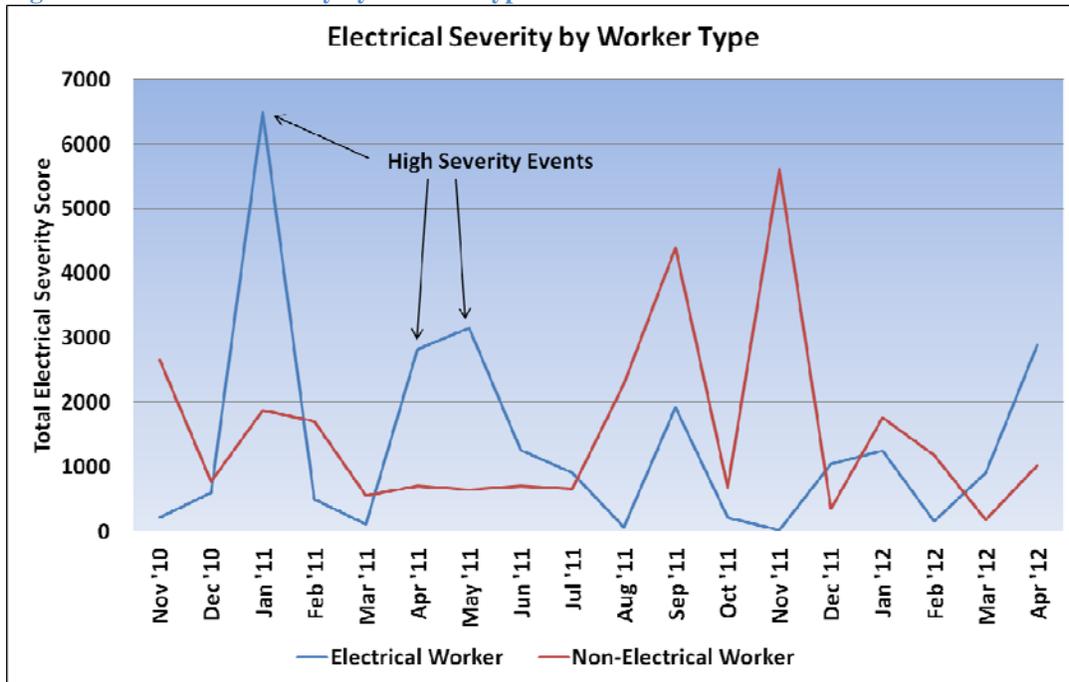
Figure 9 – Electrical Severity by Worker Type

Figure 9 shows the total electrical severity score by worker type for each month.

Electrical Workers were involved in the fewest number of occurrences but had three High-Severity events. Events involving Non-Electrical Workers usually have Low to Medium electrical severity scores but have a higher total score per month because of more occurrences.

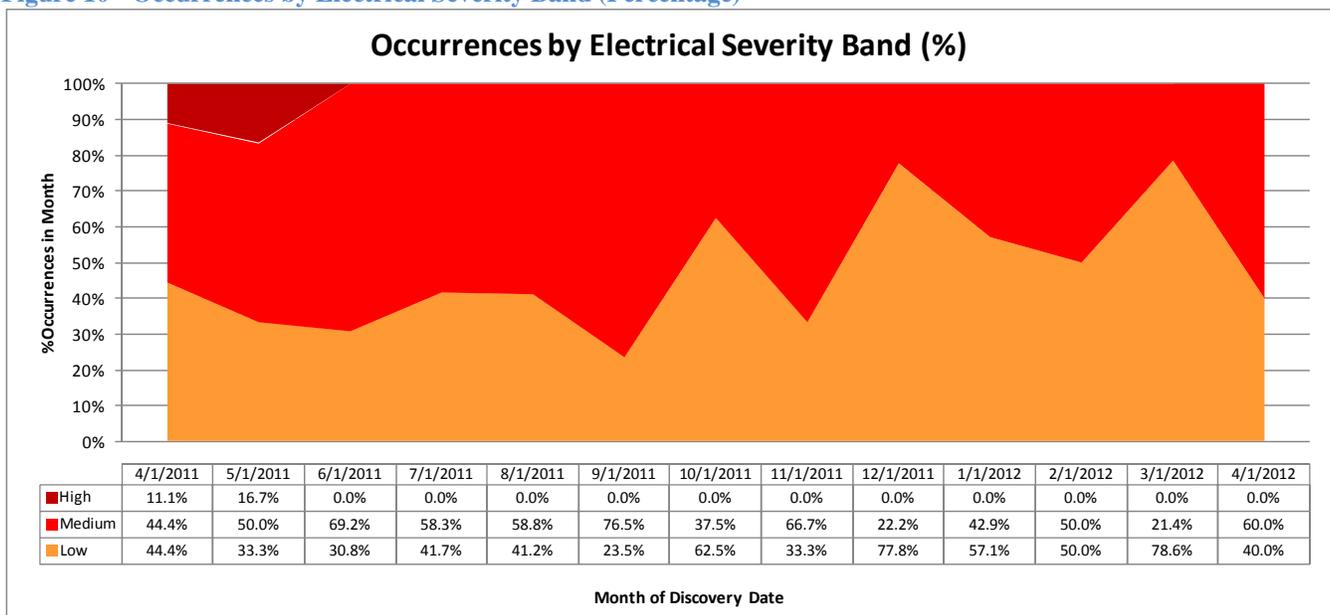
Figure 10 - Occurrences by Electrical Severity Band (Percentage)

For the interval April 2011 through April 2012 (current month and the past 12), Figures 10 and 11 summarize occurrences by severity band and month of discovery date by percentage of total occurrences in month and number of occurrences in month.

What can be seen from the previous two charts is that the number of occurrences with High electrical severity scores has remained at zero for the past 11 months and that the number of occurrences with Medium scores has increased above the number of Low severity occurrences.

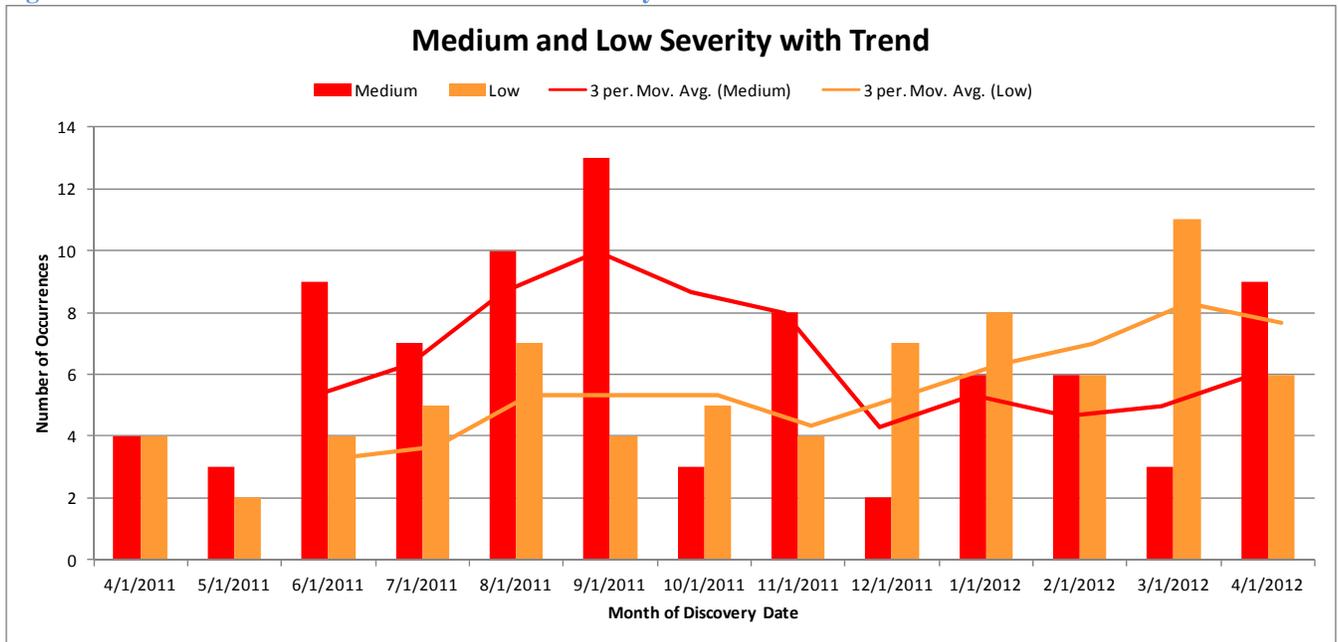
Figure 12 - Trend of Medium and Low Electrical Severity Occurrences

Figure 12 focuses on the Medium and Low severity data series for April 2011 through April 2012. Trend lines are included for each, using a 3-month moving average.

The 3-month moving average shows an increasing trend for Medium severity occurrences while Low severity occurrences decreased since last month. A higher percentage of Low severity occurrences is preferred.
