Office of Health, Safety and Security

Monthly Analysis of Electrical Safety Occurrences

August 2011

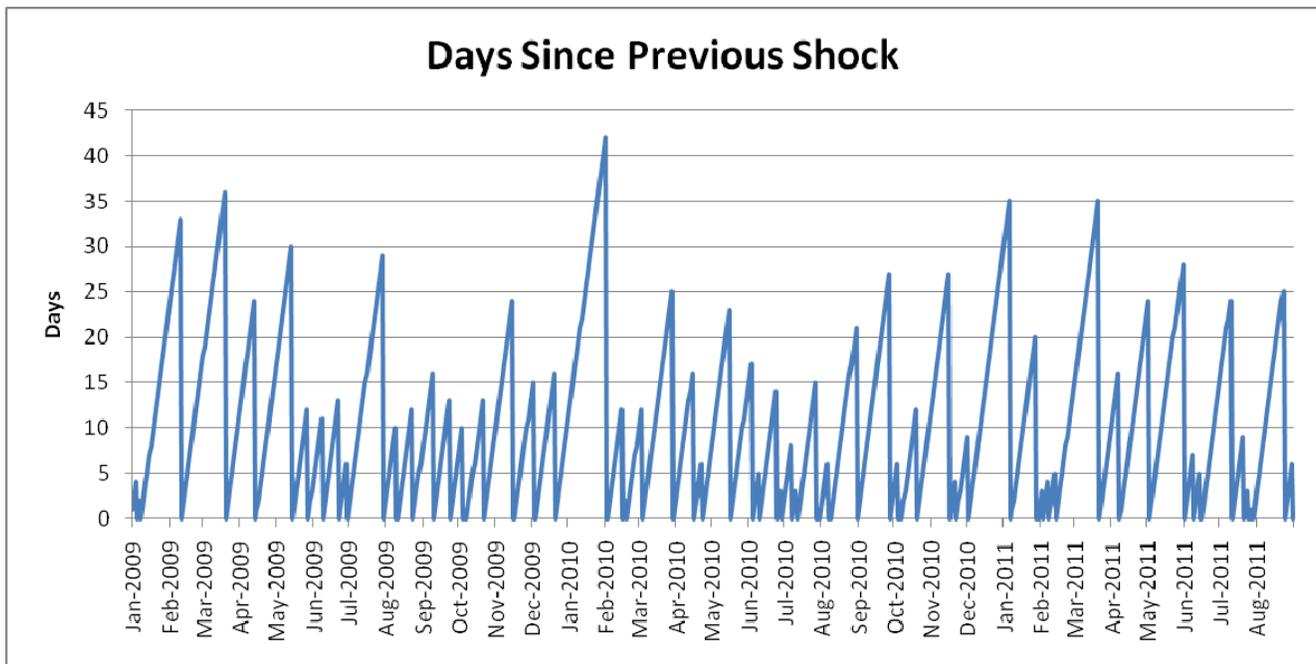
The following chart shows the number of days since the previous electrical shock for the DOE complex. The present interval is 5 days. The longest interval was 41days in 2010.

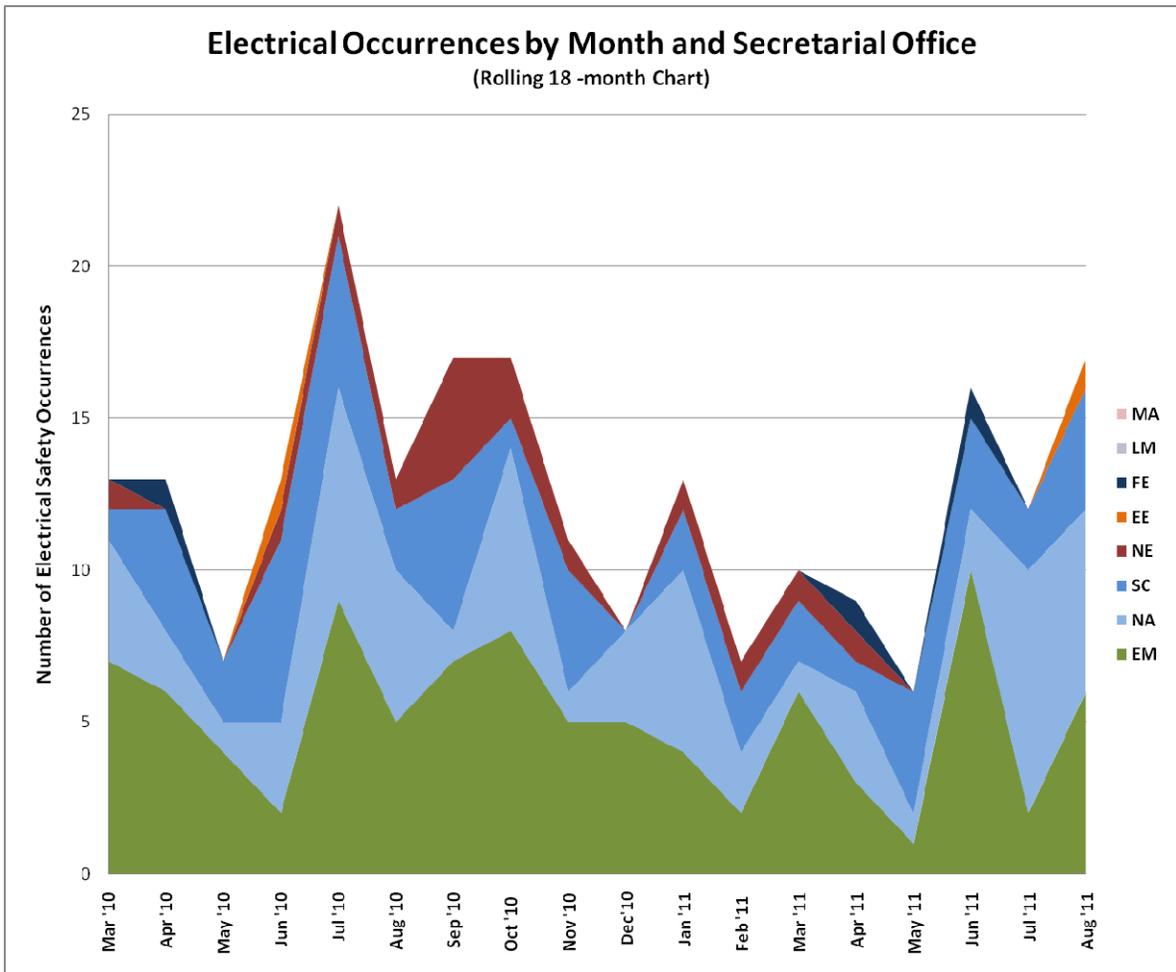
The following chart shows the distribution of electrical safety occurrences by secretarial office. As can be seen, Environmental Management sites were the largest contributor. The Office of Energy Efficiency and Renewable Energy reported their first event in over a year.

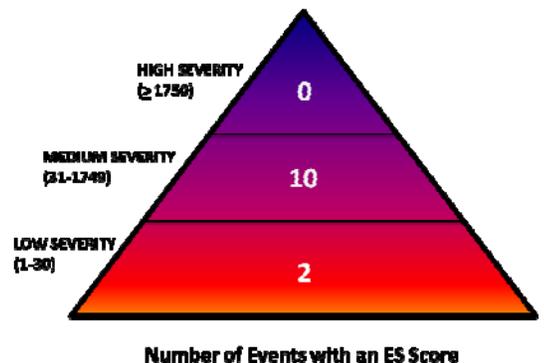
Electrical Severity Scores

The electrical severity scores are calculated using Revision 2 of the Electrical Severity Measurement Tool, which can be found on the EFCOG website at http://www.efcog.org/wg/esh_es/docs/Electrical_Severity_Measurement_Tool.pdf. Five of the electrical occurrences this month did not have an Electrical Severity (ES) score. The other twelve occurrences are distributed as shown in the triangle, with the highest ES score being 550. The actual score for each event is provided in the event tables (Attachment 1).

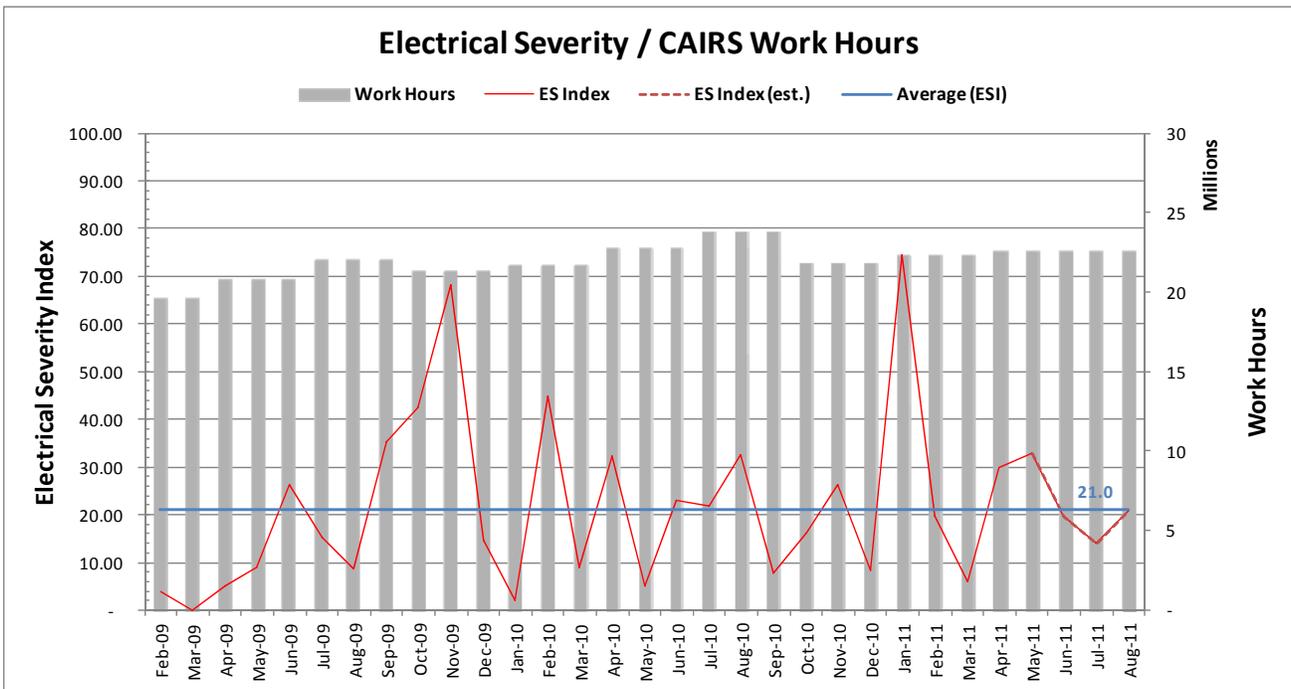
The Electrical Severity Index (ESI) is a performance metric that was developed to normalize events against organizational work hours. The ESI is calculated monthly and trended. Each DOE site calculates their own ESI and sets their own annual ESI goals. These ESI goals can vary from 0.22 to 160.0. Presently, the DOE complex goal is for the monthly ESI to be below the average ESI and to reduce the average ESI for the DOE complex to < 20.0. This average ESI goal was established based on the average ESI for 2009 (18.99) and 2010 (19.03). The following chart shows a calculated ESI for the DOE complex, which shows the present ESI just below the 30-month average ESI.

Note: An estimated ESI is calculated until accurate CAIRS man-hours are available. The chart is updated monthly.

Category	July	August	Δ
Total Occurrences	12	17	+5
Total Electrical Severity	1,578	2,360	+782
Estimated Work Hours	22,629,691* (22,629,691)	22,630,393	+702
ES Index	13.95* (13.95)	20.86	+6.91
Average ESI	21.0	21.0	0.0

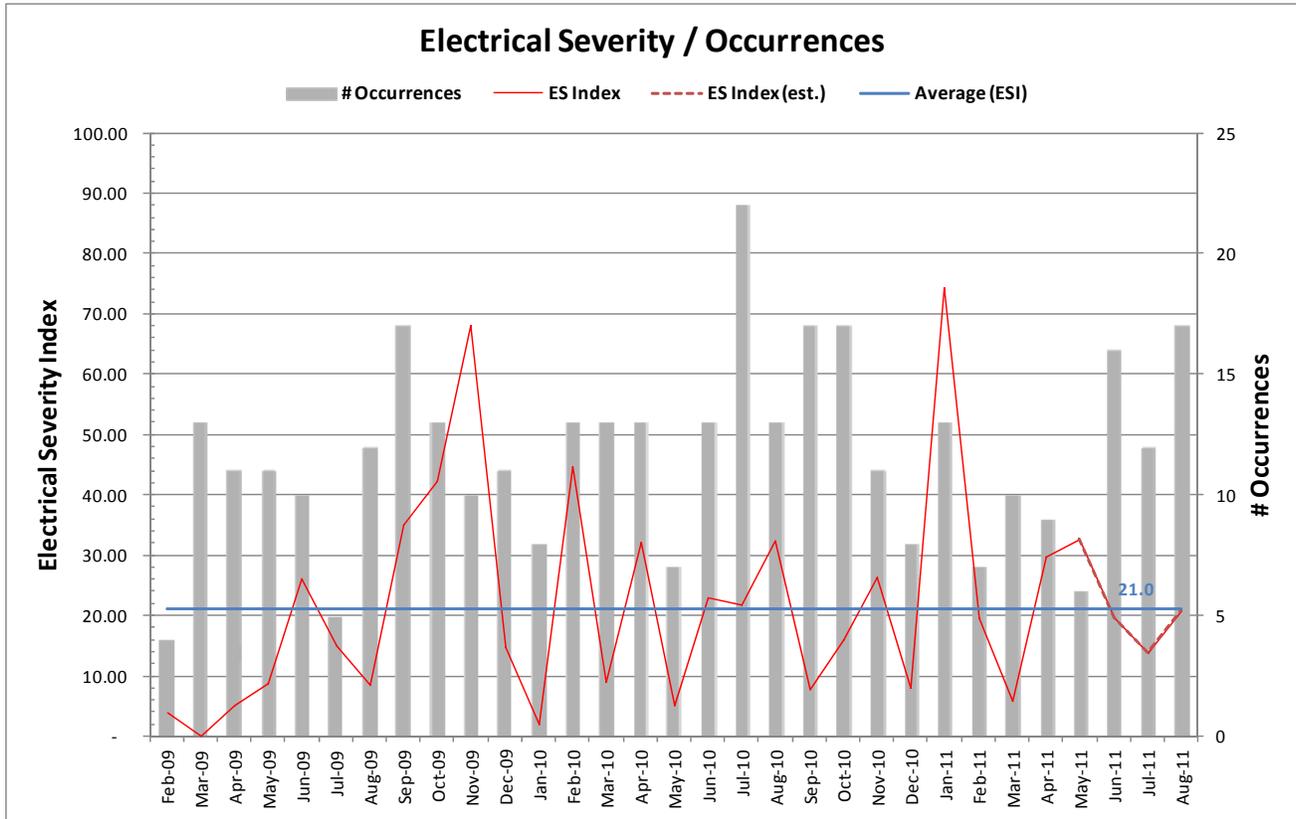
The following chart shows the ESI with the number of Occurrences instead of Work Hours.

The average ESI has increased from 19.2 in June 2010 to 21.0 in August 2011. The following chart shows the number of days since the previous high severity occurrence. The present interval is 116 days. The longest interval was 181 days in 2009.

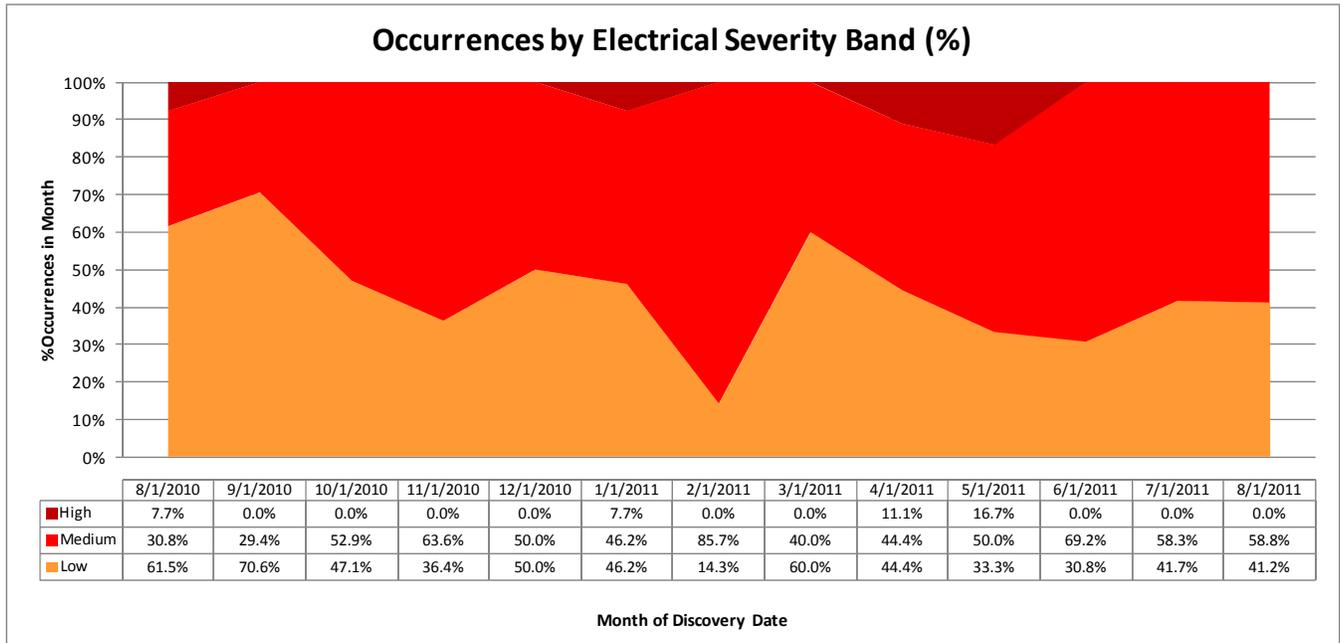
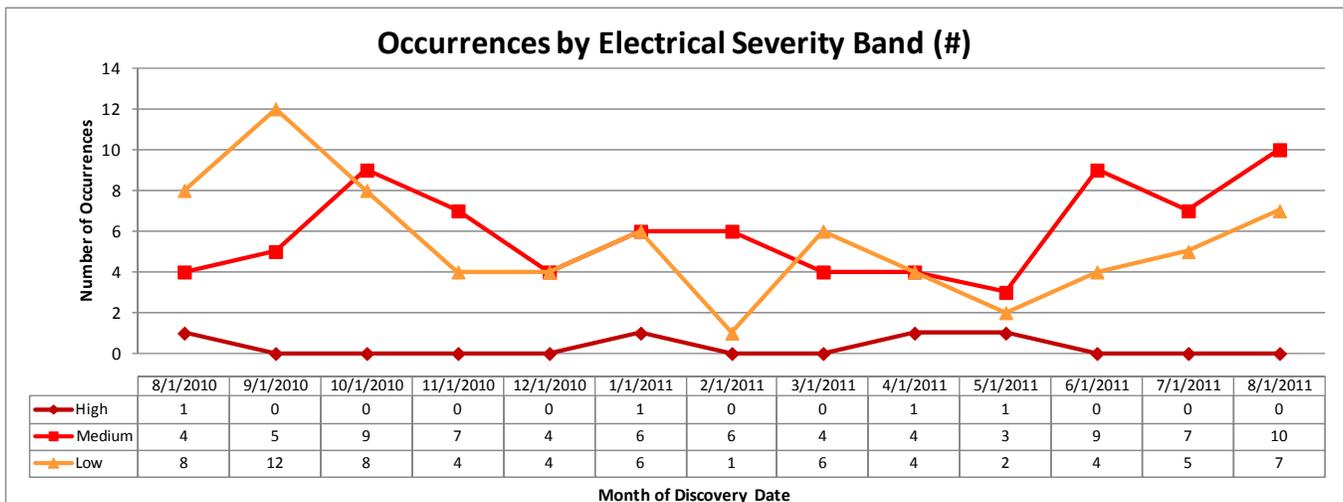
Summary of Occurrences by Severity Band

For the interval August 2010 through August 2011 (current month and the past 12), the next two charts summarize occurrences by severity band and month of discovery date:

- By percentage of total occurrences in month
- By number of occurrences in month

What can be seen from the previous two charts is that the number of occurrences with High electrical severity scores has remained at zero for the past three months and that the number of occurrences with Medium and Low scores have increased. It is more desirable to see more Low than Medium severity occurrences as was seen in September 2010 and March 2011.

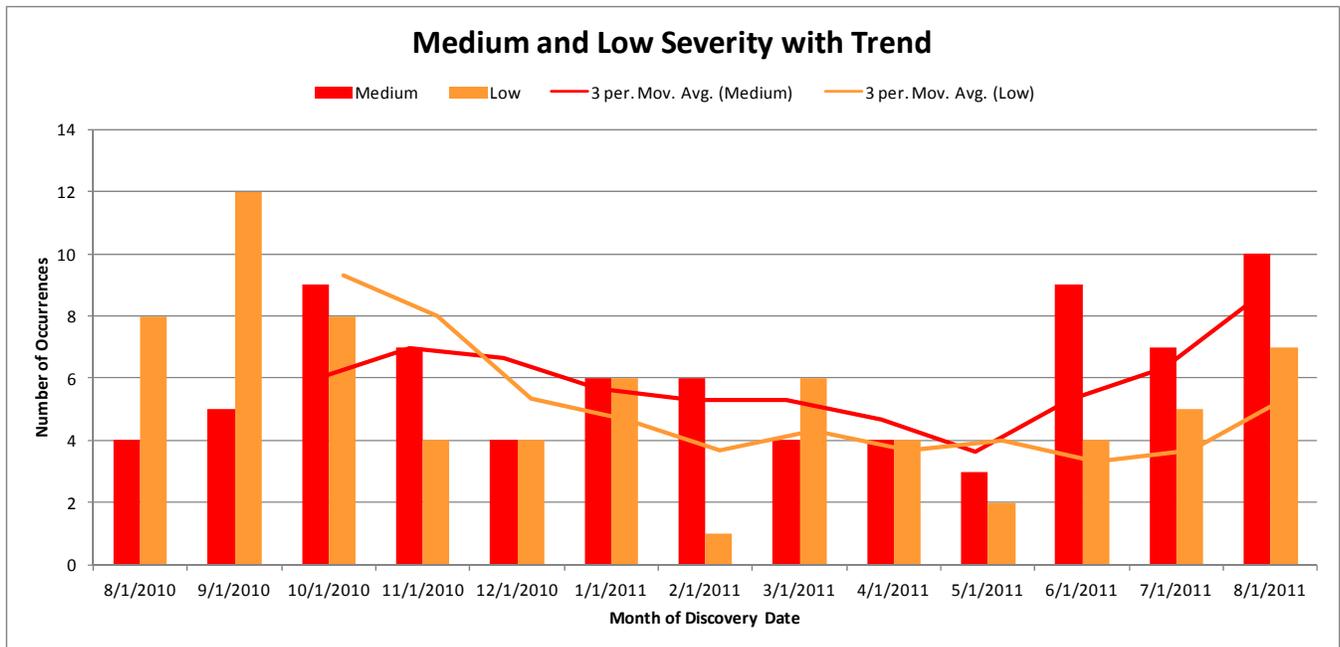
Medium and Low Severity with Trend

The following chart focuses on the Medium and Low severity data series for August 2010 through August 2011. Trend lines are included for each, using a 3-month moving average.

The 3-month moving average shows an increase in the Medium and Low severity occurrences since May 2011.
