Office of Health, Safety and Security

Monthly Analysis of Electrical Safety Occurrences

September 2011

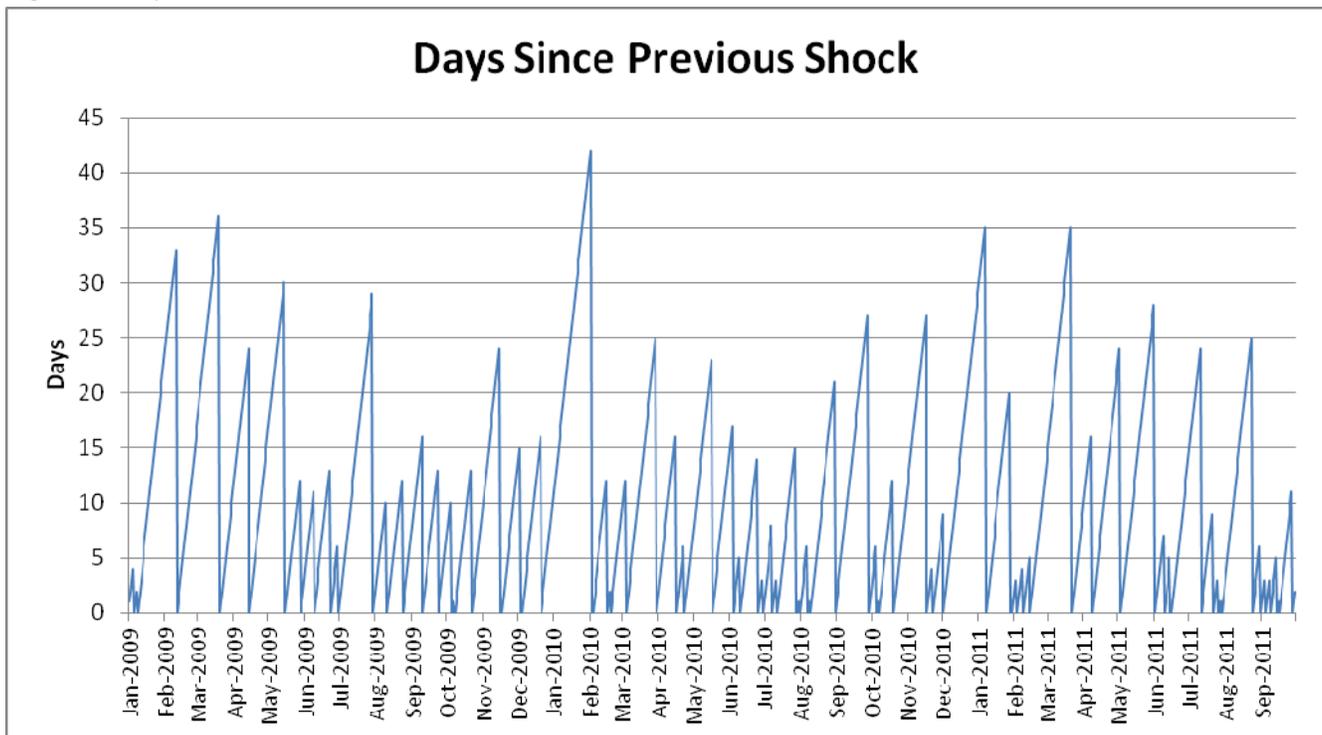
Figure 1 - Days since Previous Shock

Figure 1 shows the number of days since the previous electrical shock for the DOE complex. The present interval is 2 days. The longest interval was 41 days in 2010.

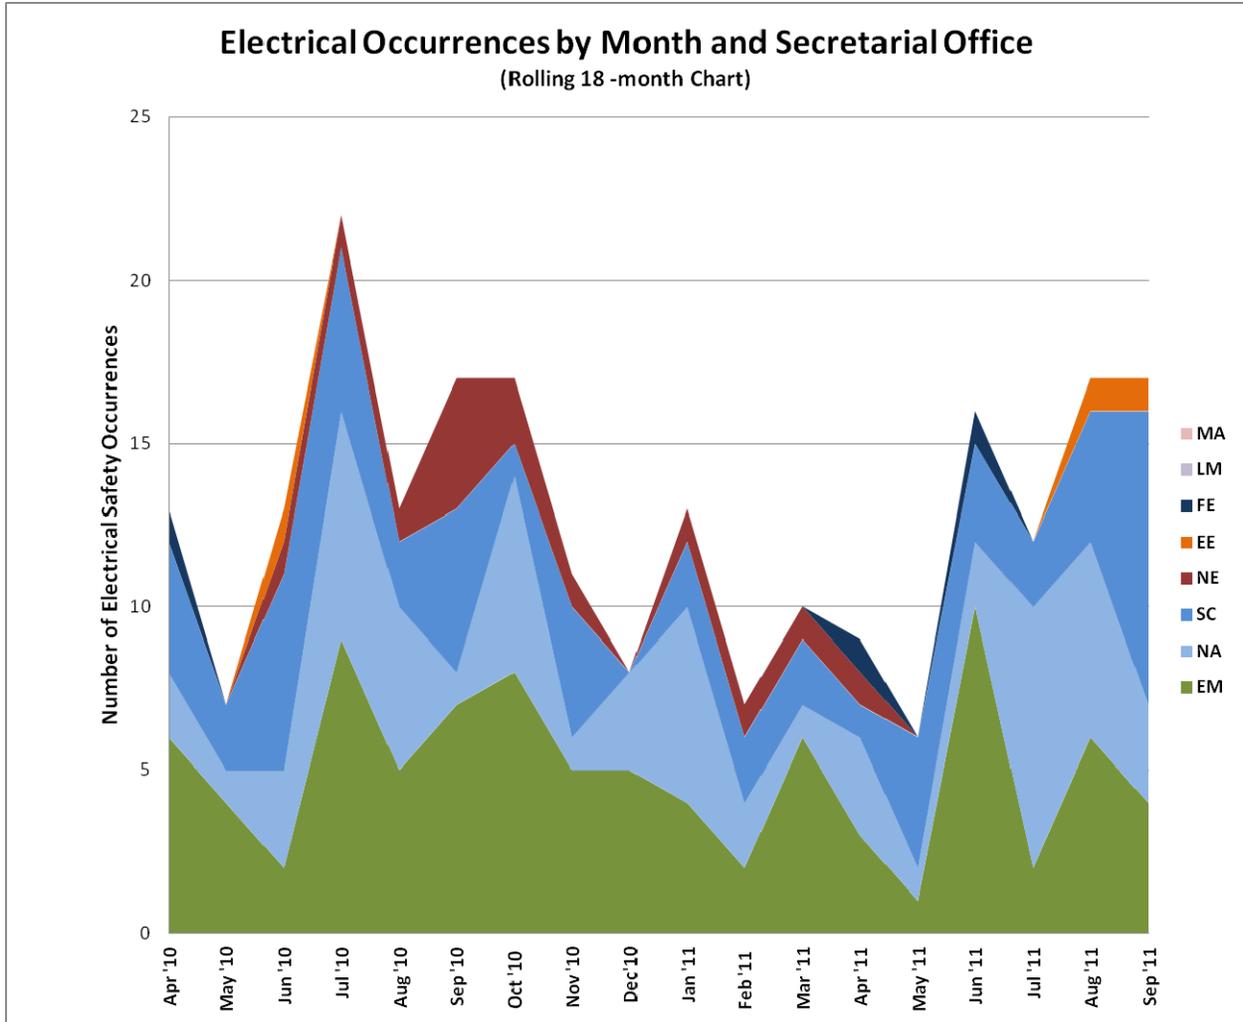
Figure 2 - Electrical Occurrences by Month and Secretarial Office

Figure 2 shows the distribution of electrical safety occurrences by secretarial office. As can be seen, the Office of Science laboratories and sites were the largest contributor. The Office of Nuclear Energy hasn't reported an occurrence since April 2011.

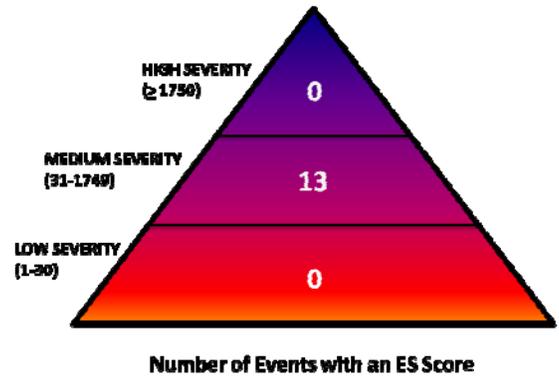
Figure 3 - Electrical Severity Count

The electrical severity scores are calculated using Revision 2 of the Electrical Severity Measurement Tool, which can be found on the EFCOG website at http://www.efcog.org/wg/esh_es/docs/Electrical_Severity_Measurement_Tool.pdf. Four of the electrical occurrences this month did not have an Electrical Severity (ES) score. The other thirteen occurrences are distributed as shown in Figure 3, with the highest ES score being 1650. The actual score for each occurrence is provided in Attachment 1.

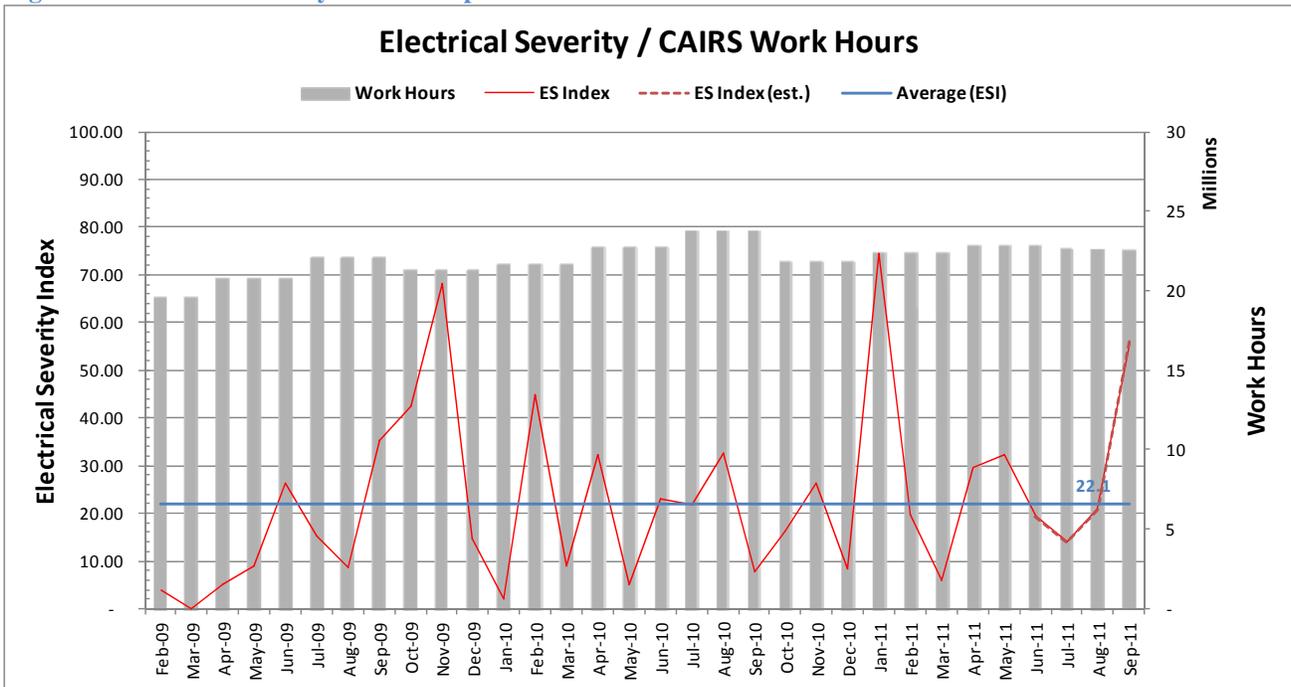
Figure 4 - Electrical Severity Index Compared to Work Hours

The Electrical Severity Index (ESI) is a performance metric that was developed to normalize events against organizational work hours. The ESI is calculated monthly and trended. Each DOE site calculates their own ESI and sets their own annual ESI goals. These ESI goals can vary from 0.22 to 160.0. Presently, the DOE complex goal is for the monthly ESI to be below the average ESI and to reduce the average ESI for the DOE complex to < 20.0. This average ESI goal was established based on the average ESI for 2009 (18.99) and 2010 (19.03). Figure 4 shows a calculated ESI for the DOE complex. The present ESI has increased to its highest level since January 2011 and is the third highest during the 32-month period.

Note: An estimated ESI is calculated until accurate CAIRS man-hours are available. The chart is updated monthly.

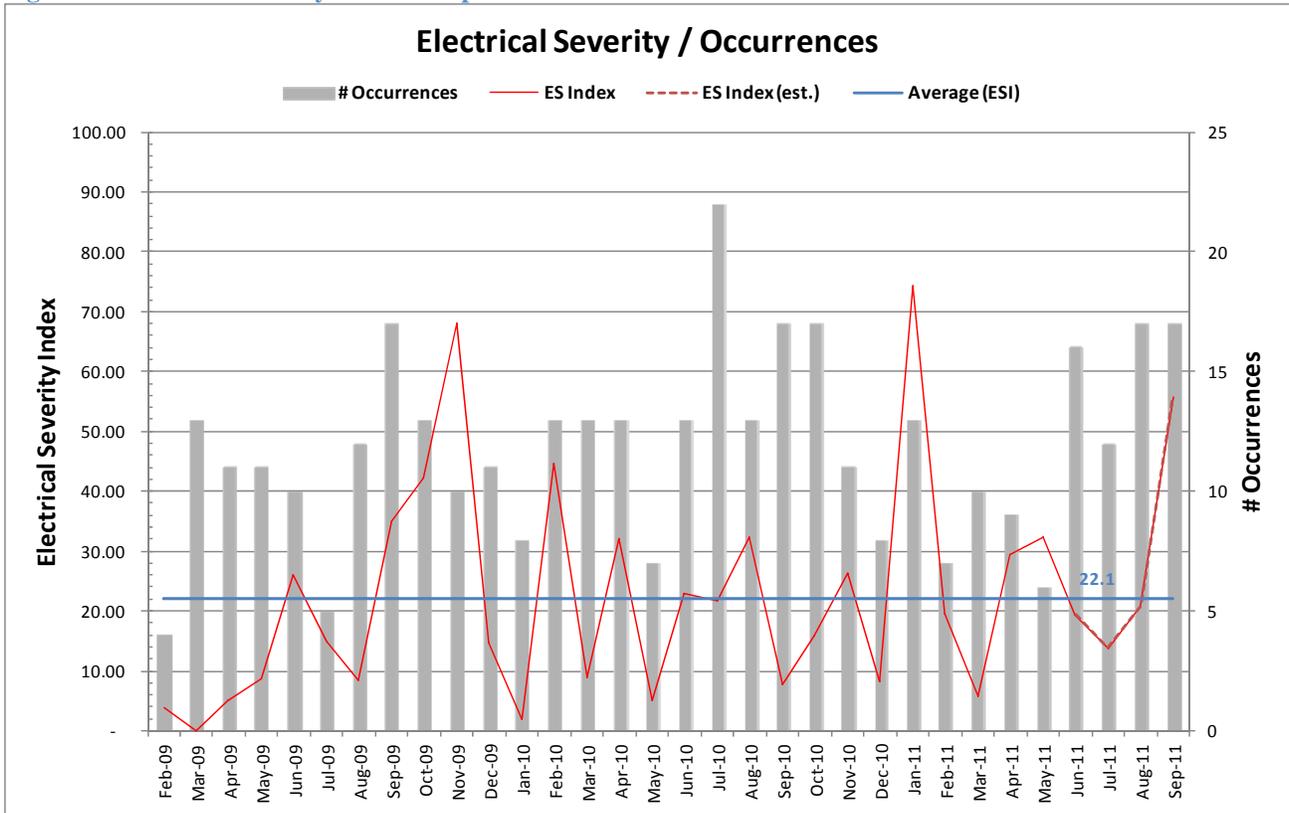
Figure 5 - Electrical Severity Index Compared to Number of Occurrences

Figure 5 shows the ESI with the number of Occurrences instead of Work Hours.

The average ESI has increased from 19.2 in June 2010 to 22.1 in September 2011.

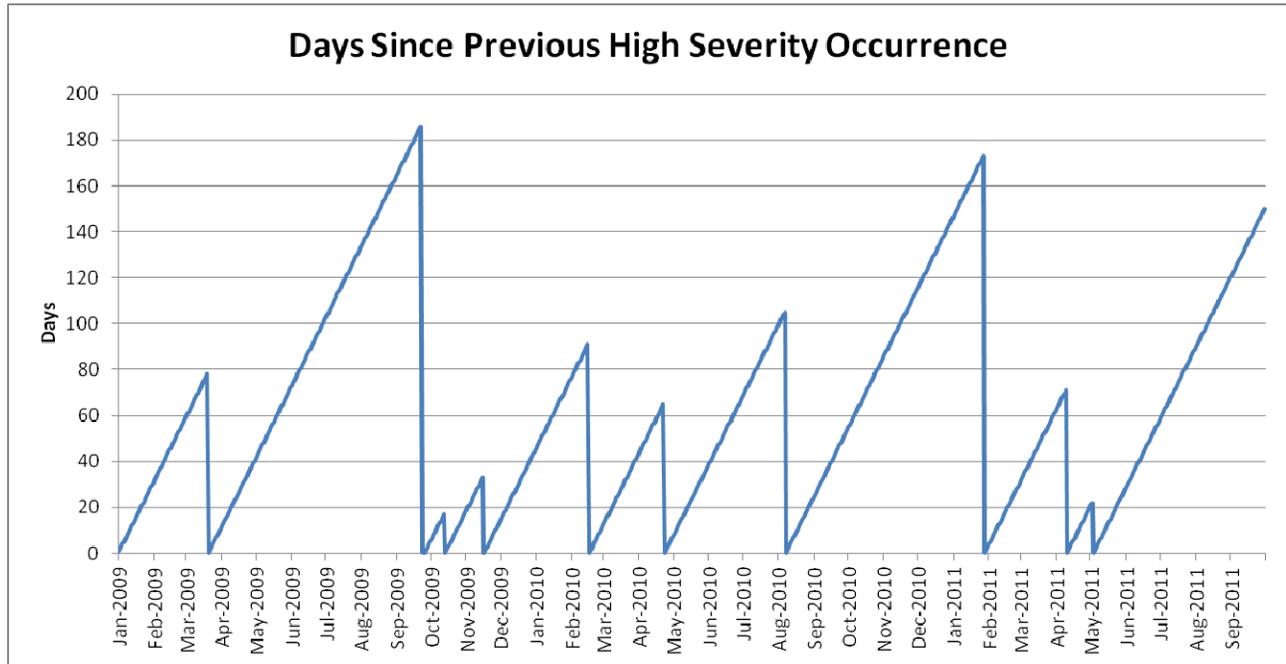
Figure 6 - Days since Previous High Severity Occurrence

The following chart shows the number of days since the previous high severity occurrence. The present interval is 150 days. The longest interval was 181 days in 2009.

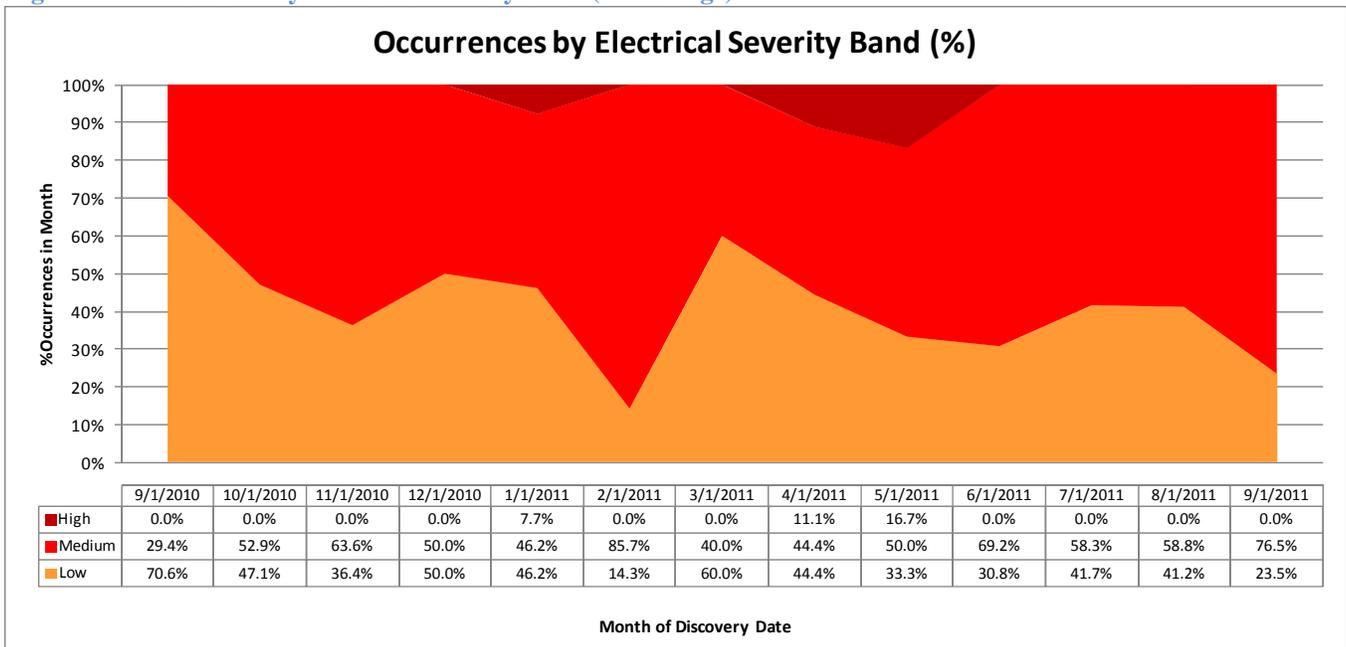
Figure 7 - Occurrences by Electrical Severity Band (Percentage)

For the interval September 2010 through September 2011 (current month and the past 12), Figures 7 and 8 summarize occurrences by severity band and month of discovery date by percentage of total occurrences in month and number of occurrences in month.

What can be seen from the previous two charts is that the number of occurrences with High electrical severity scores has remained at zero for the past four months and that the number of occurrences with Medium scores have steadily increased. It is more desirable to see more Low than Medium severity occurrences as was seen in September 2010 and March 2011.

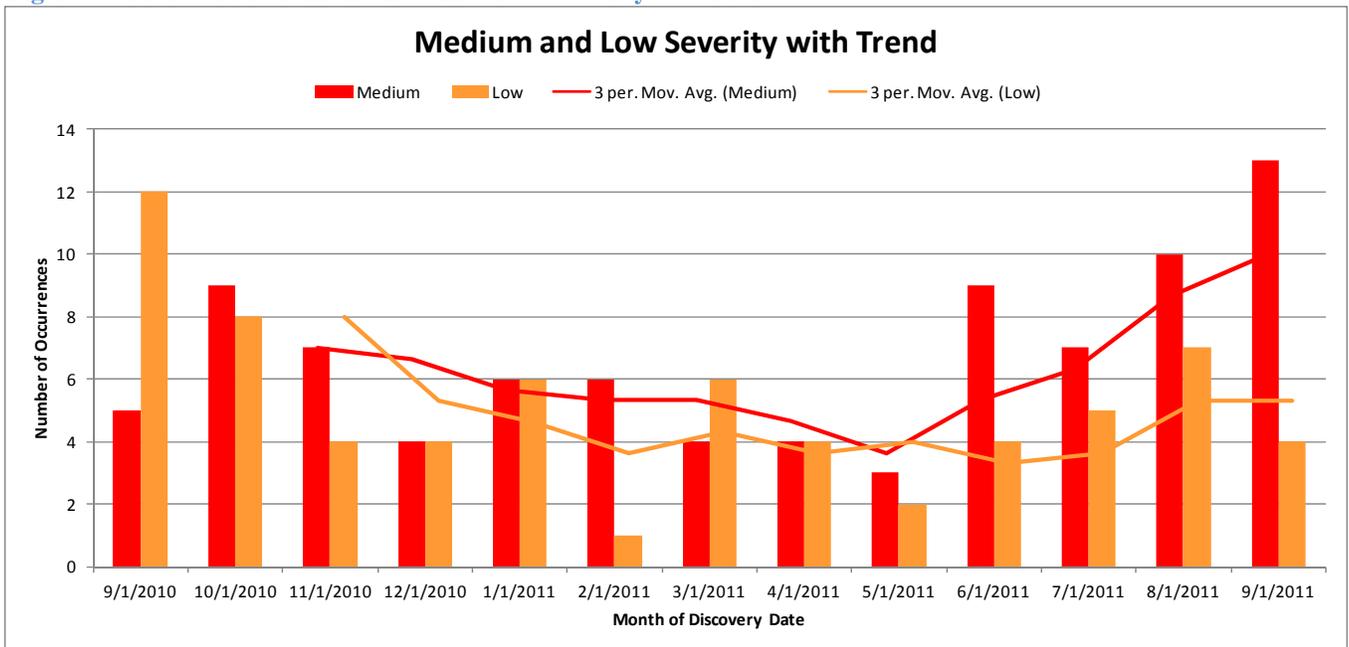
Figure 9 - Trend of Medium and Low Electrical Severity Occurrences

Figure 9 focuses on the Medium and Low severity data series for September 2010 through September 2011. Trend lines are included for each, using a 3-month moving average.

The 3-month moving average shows an increase in the Medium severity occurrences since May 2011 and a leveling off off Low severity occurrences.
