Office of Health, Safety and Security

Monthly Analysis of Electrical Safety Occurrences

September 2012

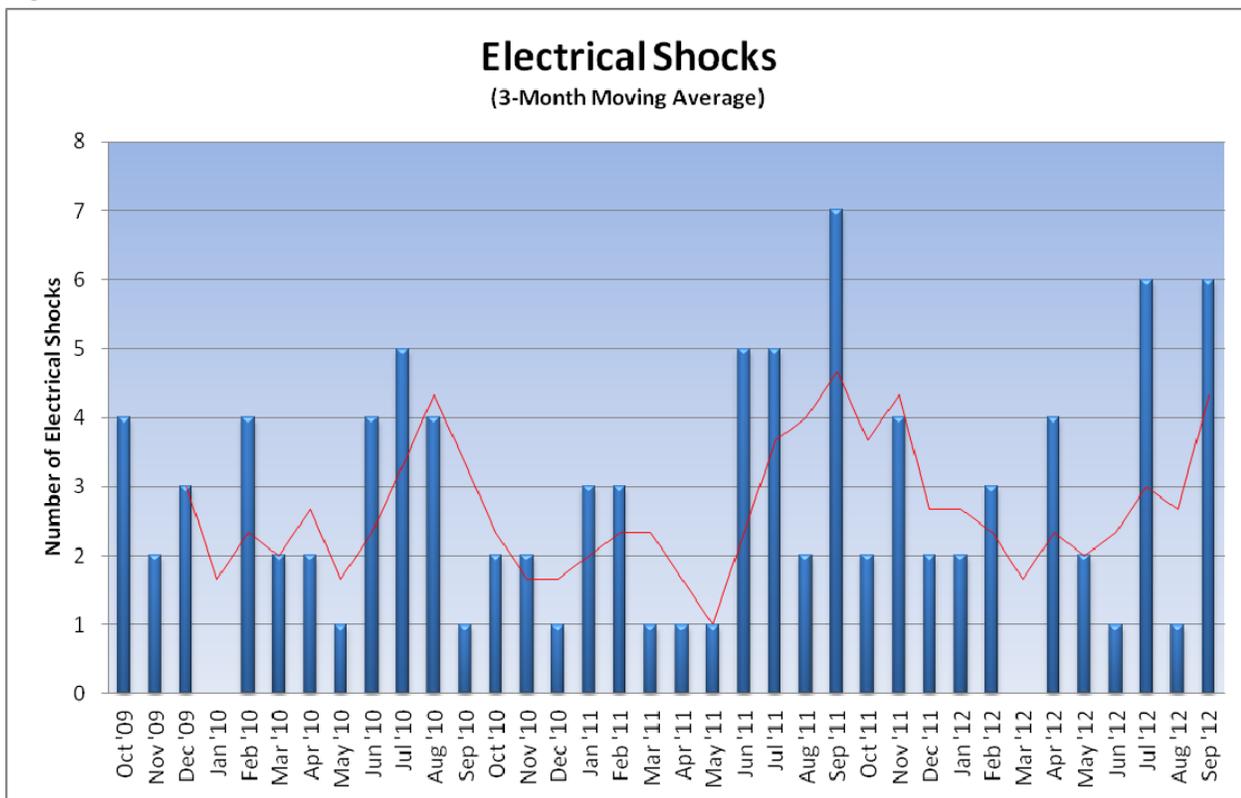
Figure 1 – Three-Year Trend of Electrical Shocks

Figure 1 shows a 3-year trend of electrical shocks for the DOE complex. During this period, the average number of electrical shocks has remained below three shocks per month.

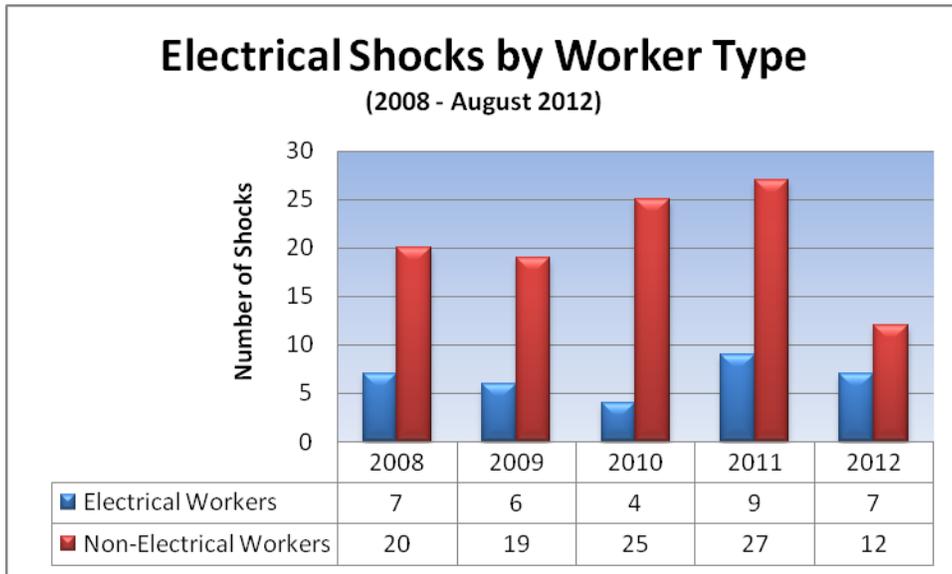
Figure 2 - Electrical Shock by Worker Type

Figure 2 shows electrical shocks by worker type. The majority of shocks (about 75 percent) involve non-electrical workers.

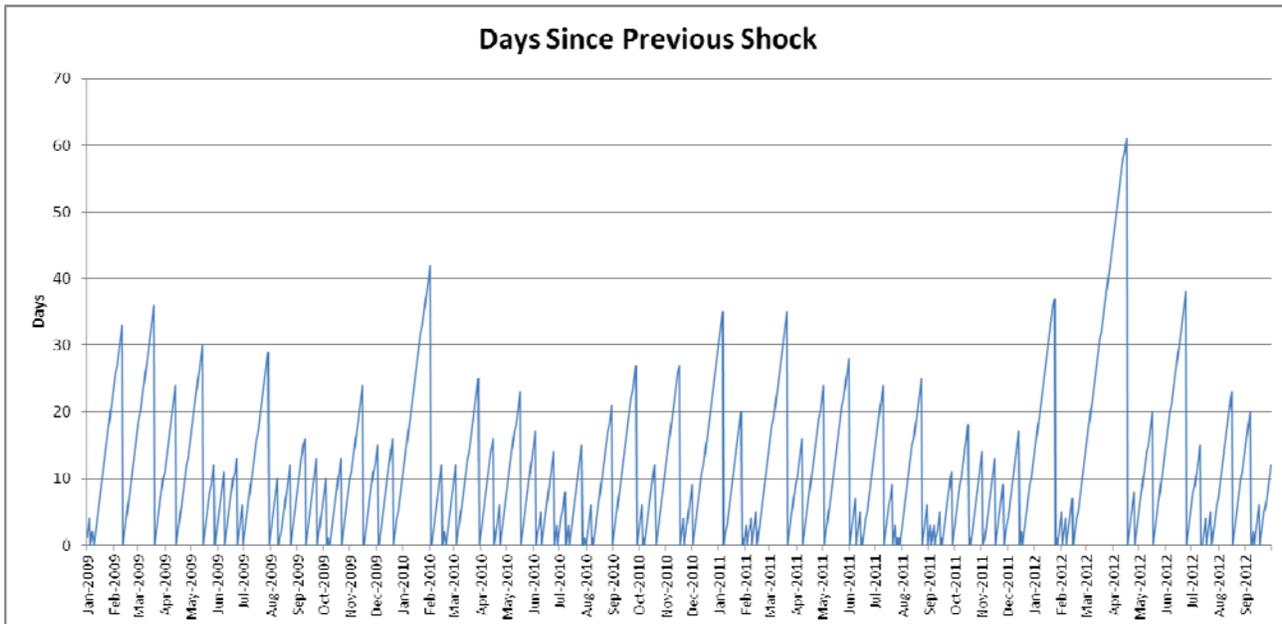
Figure 3 - Days since Previous Shock

Figure 3 shows the number of days since the previous electrical shock for the DOE complex. The longest interval was 61 days (April 16, 2012) and the present interval is 12 days as of September 30.

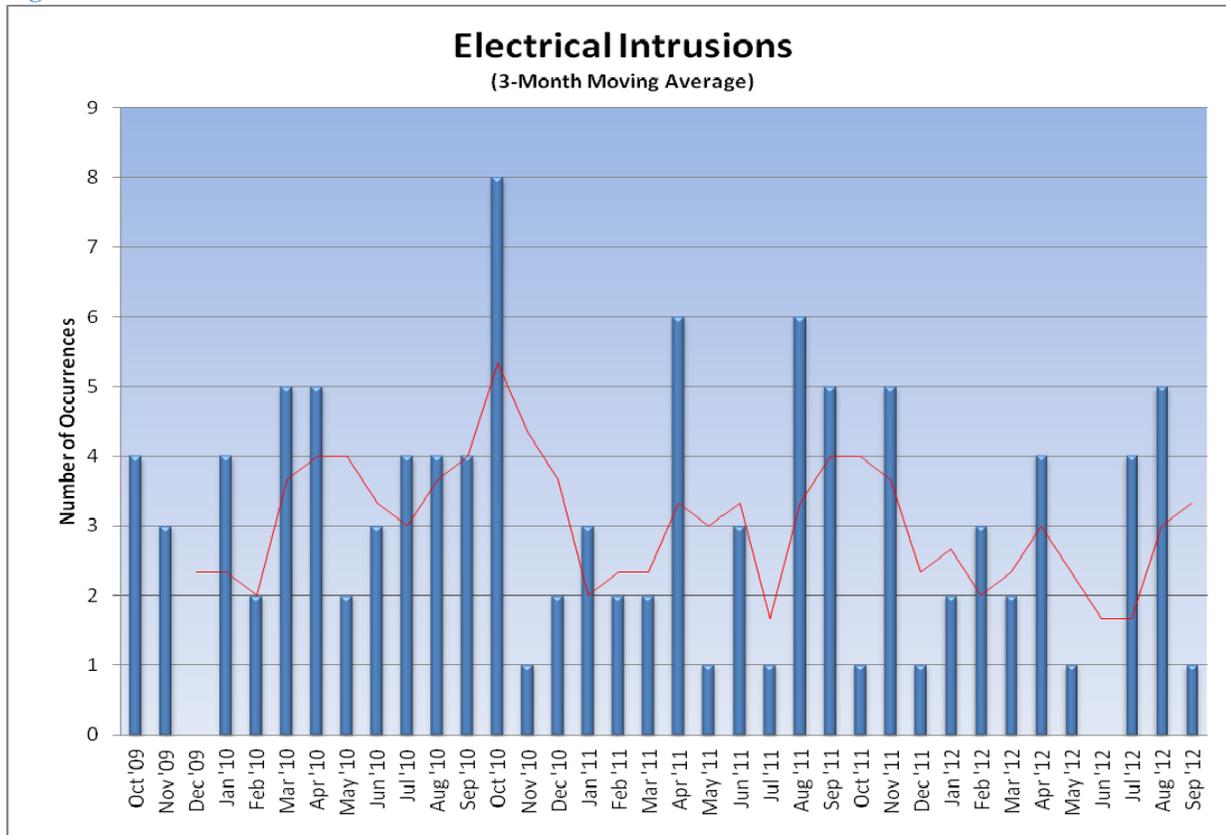
Figure 4 – Three-Year Trend of Electrical Intrusion Occurrences

Figure 4 shows a 3-year trend of electrical intrusion occurrences for the DOE complex. During this period we have seen an average of 3 occurrences per month.

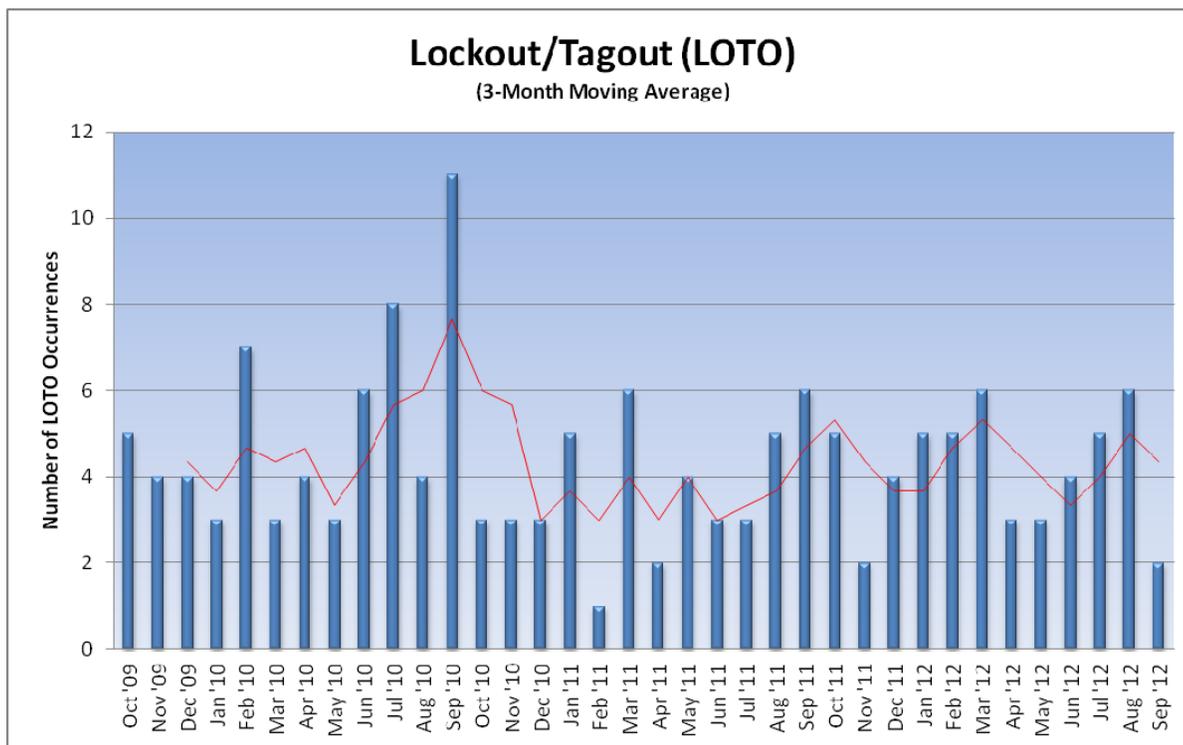
Figure 5 – Three-Year Trend of Lockout/Tagout Occurrences

Figure 5 shows a 3-year trend of LOTO occurrences for the DOE complex. Although there was an increase in the number of occurrences since June, a large drop occurred September. The monthly average is 4.3 occurrences.

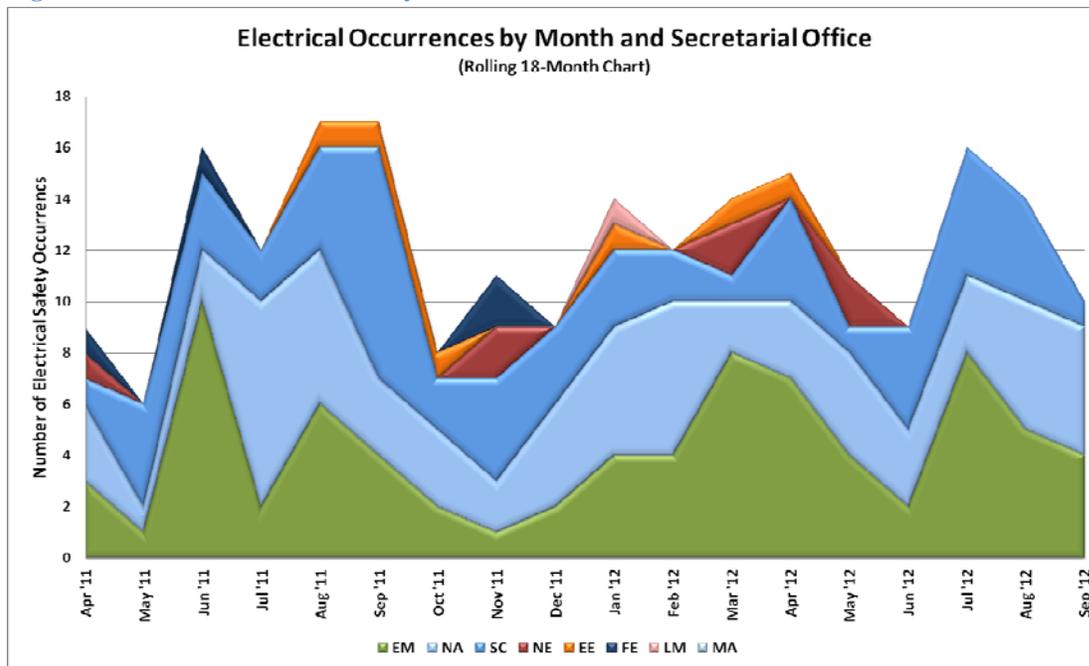
Figure 6 - Electrical Occurrences by Month and Secretarial Office

Figure 6 shows the distribution of electrical safety occurrences by Secretarial Office

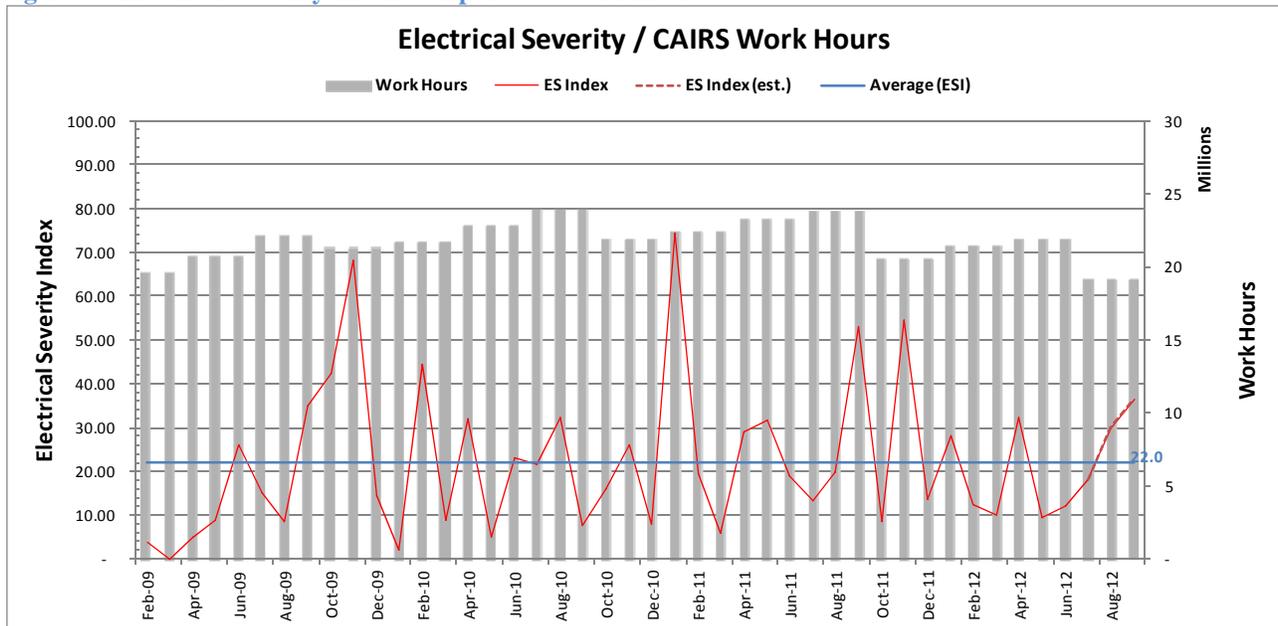
Figure 7 - Electrical Severity Index Compared to Work Hours

The Electrical Severity Index (ESI) is a performance metric that was developed to normalize events against organizational work hours. The ESI is calculated monthly and trended. Figure 7 shows a calculated ESI for the DOE complex and Table 4 shows the ESI and how it has changed from the previous month.

Note: An estimated ESI is calculated until accurate CAIRS man-hours are available. The chart is updated monthly.

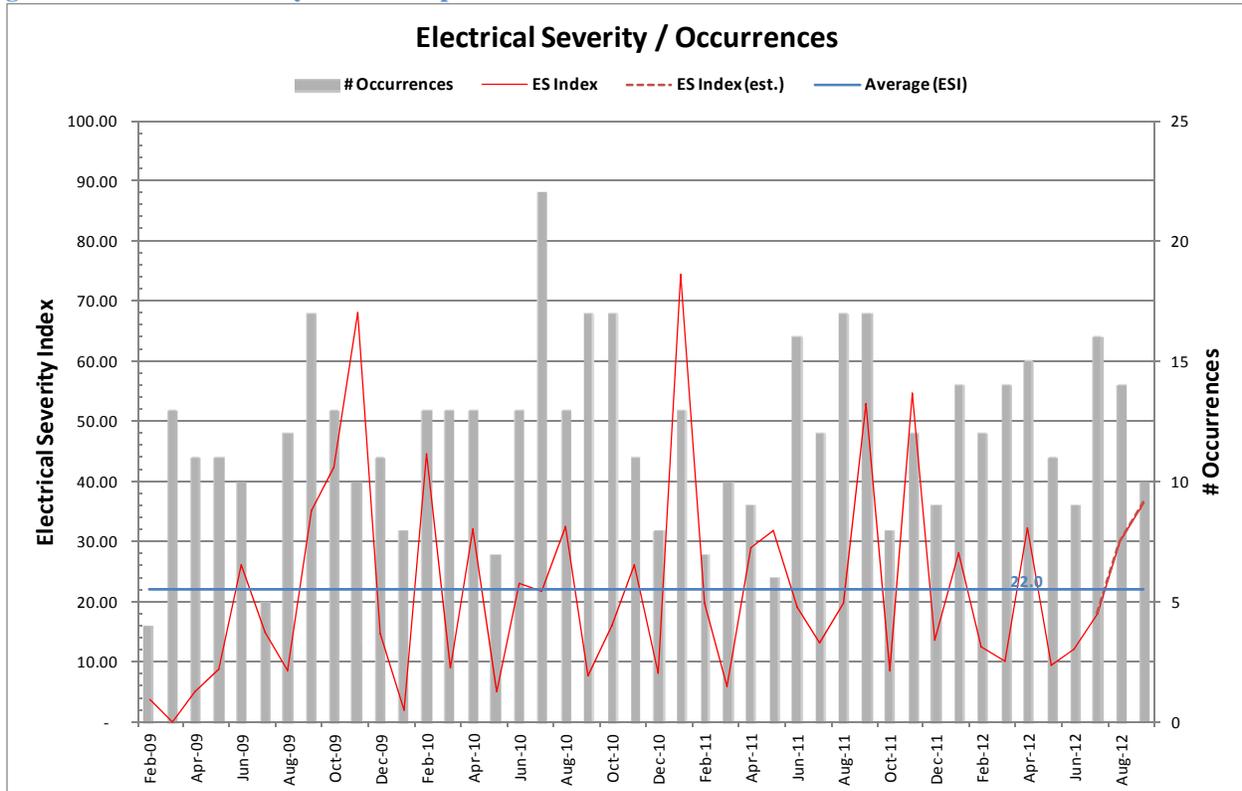
Figure 8 - Electrical Severity Index Compared to Number of Occurrences

Figure 8 shows the ESI with the number of Occurrences instead of Work Hours.

The average ESI (22.0) has increased slightly from last month. The lowest average ESI was 19.2 in June 2010.

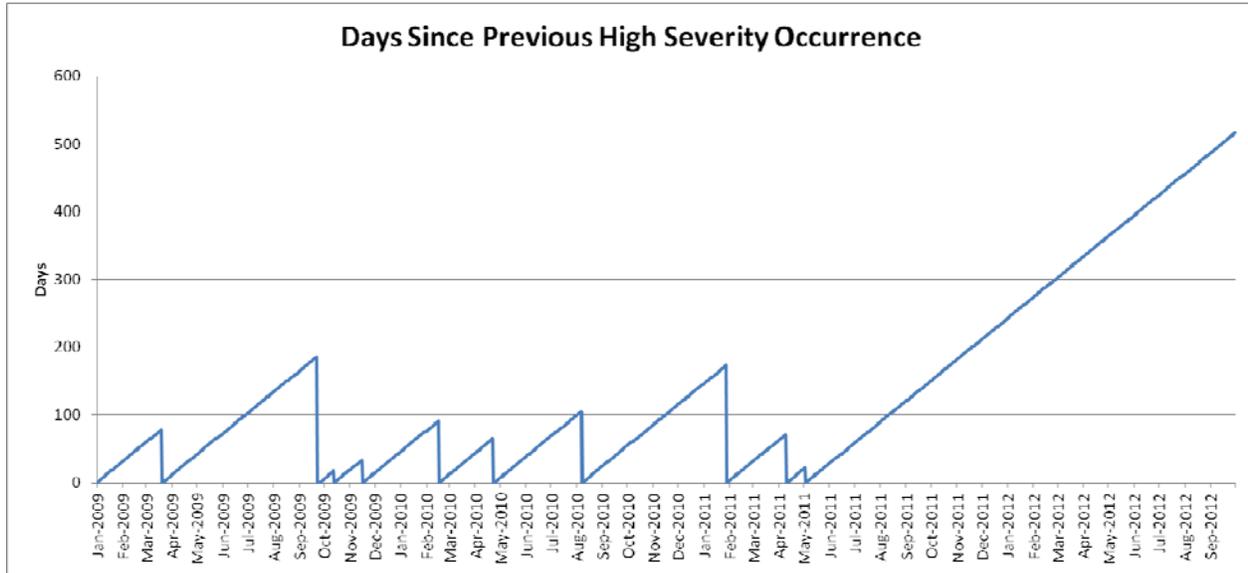
Figure 9 - Days since Previous High Severity Occurrence

Figure 9 shows the number of days since the previous high severity occurrence. The present interval is 516 days as of September 30. The previous longest interval was 181 days in 2009.

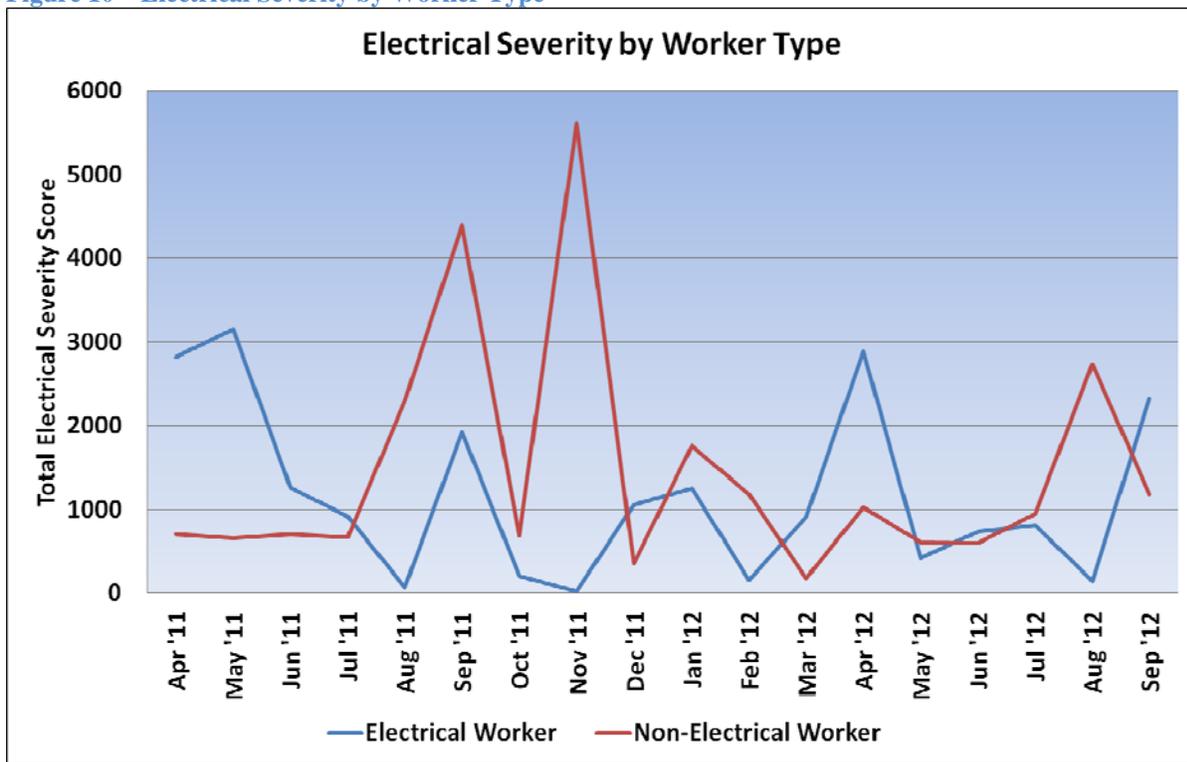
Figure 10 – Electrical Severity by Worker Type

Figure 10 shows the total electrical severity score by worker type for each month.

Electrical workers typically have the fewest number of occurrences but in September they had the majority of the occurrences and the higher total ES score (2,320), while non-electrical workers ES scores totaled 1,180. The average ES scores for the 18 month period are 1,227 for electrical workers and 1,464 for non-electrical workers. Note: Electrical workers had two high severity events in April and May 2011.

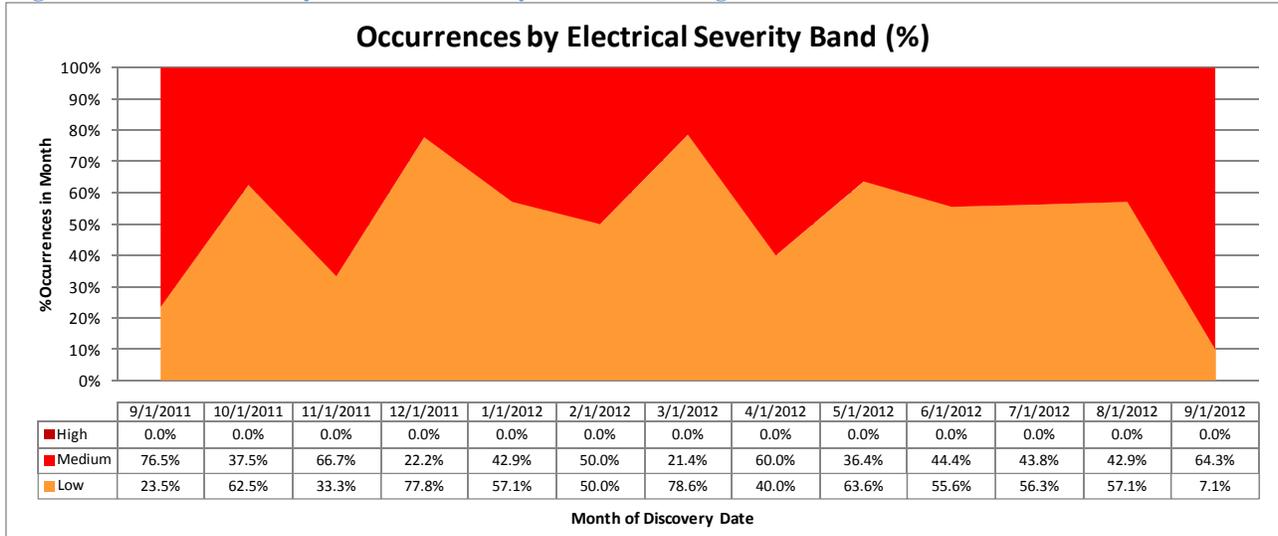
Figure 11 - Occurrences by Electrical Severity Band (Percentage)

For the interval September 2011 through September 2012 (current month and the past 12), Figures 11 and 12 summarize occurrences by severity band and month of discovery date by percentage of total occurrences in month and number of occurrences in month.

What can be seen from the previous two charts is that the number of occurrences with High electrical severity scores has remained at zero for the past 14 months and that the number of occurrences with Medium scores increased as the number of Low and zero severity occurrences decreased.

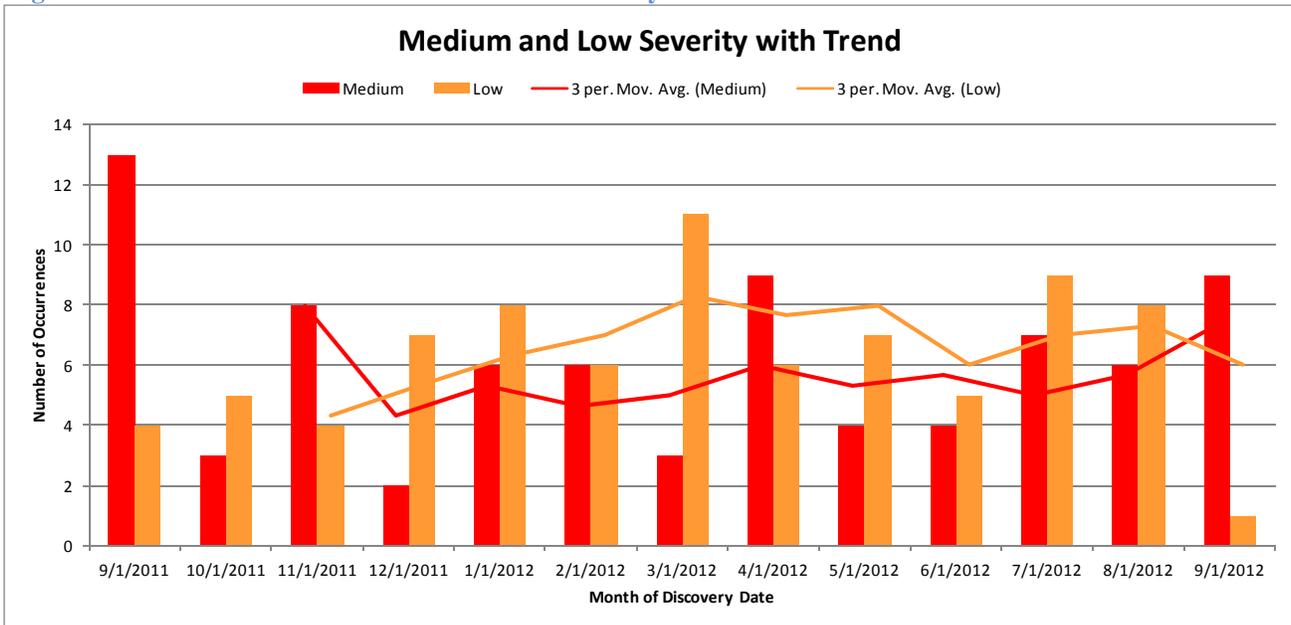
Figure 13 - Trend of Medium and Low Electrical Severity Occurrences

Figure 13 focuses on the Medium and Low severity data series for September 2011 through September 2012. Trend lines are included for each, using a 3-month moving average.

The 3-month moving average shows an increasing trend for Medium severity occurrences and a decreasing trend for Low severity occurrences. A higher percentage of Low severity occurrences is preferred.
